ILC-HiGrade cavities as a tool of quality control for the EXFEL and further SRF R&D

- Motivation and goal
- European EXFEL/ILC-HiGrade program
- Results of cold RF test of the EXFEL/ILC-HiGrade cavities
- Quality control tools and actual results

Aliaksandr Navitski *aliaksandr.navitski@desy.de

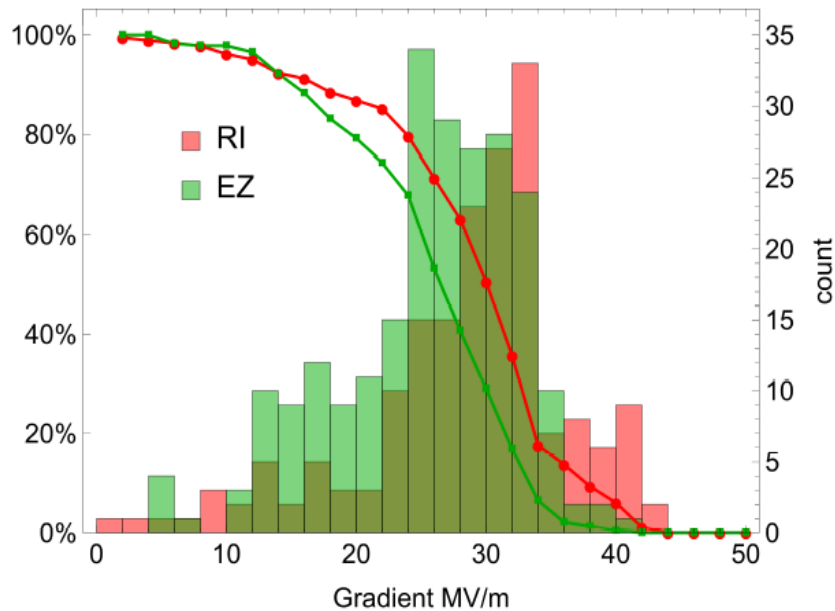
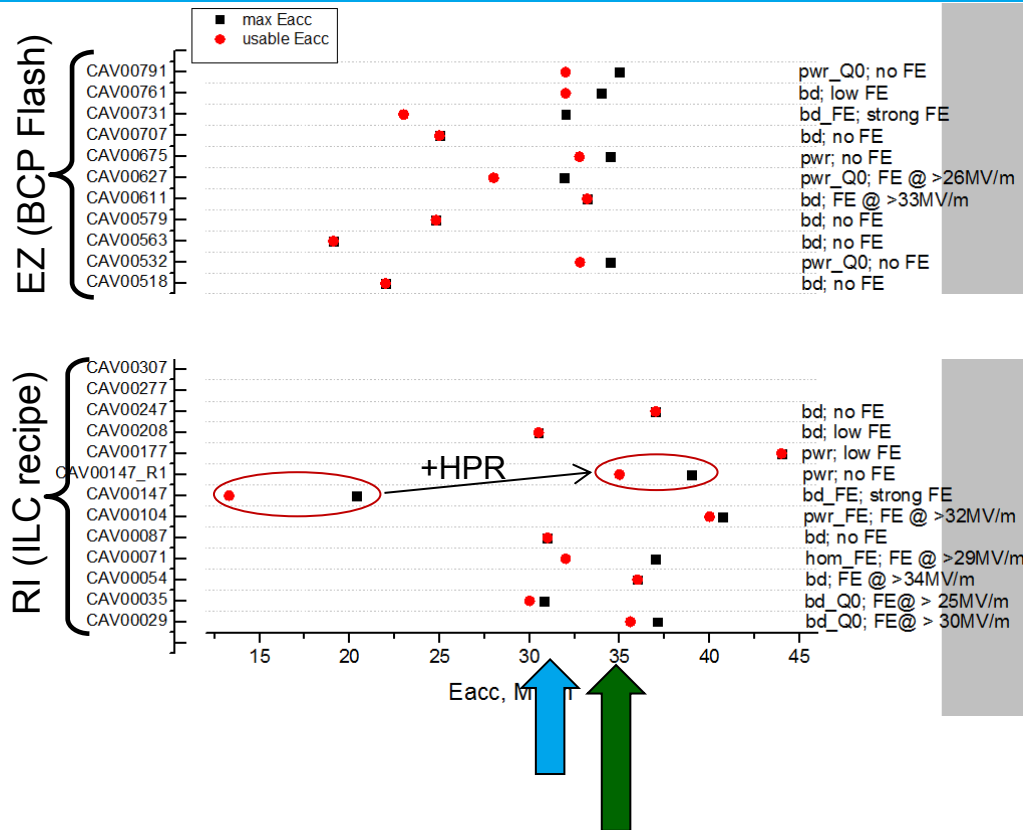
- “ILC recipe” provides cavities with usable gradient of $\sim 31.9 \pm 8.2$ MV/m (34.9 ± 4.7 MV/m after retreatment)
- some achieve >40 MV/m

- Main limitation is **FE**

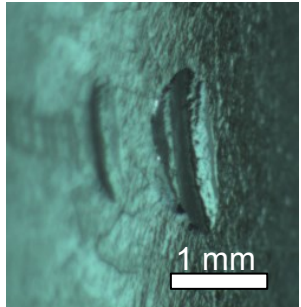
Scratches

=> **Handling failures:**

- ⊖ Strong x-ray radiation
- ⊖ Complicated repair required (tank removal, mechanical polishing inside cavities, and 2nd whole surface prepare pass)
- ⊕ Some failures identified and fixed

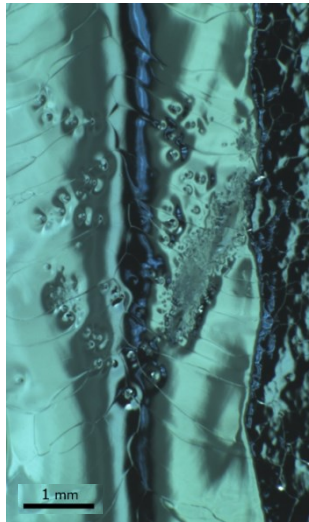
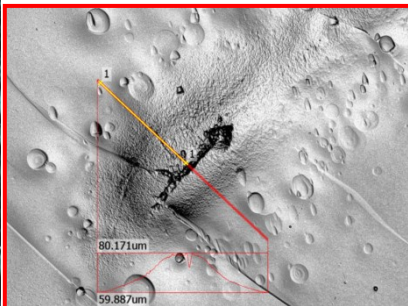
Pits or inclusions

=> Foreign material inclusions:

- ⊘ Low field quenches
- ⊘ Influence polishing process
- ⊘ Complicated repair required

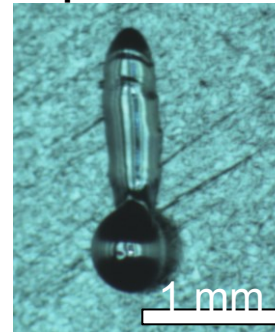
“Spatters”

- => **Welding failures due to sparks or presence of dust**
- ⊘ Low field quenches
 - ⊘ Mechanical polishing inside cavities required

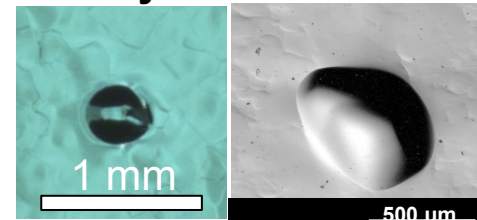
“Cat eyes”

- => **Voids in the surface**
- ⊕ Seems to be harmless
 - ⊕ No performance degradation observed

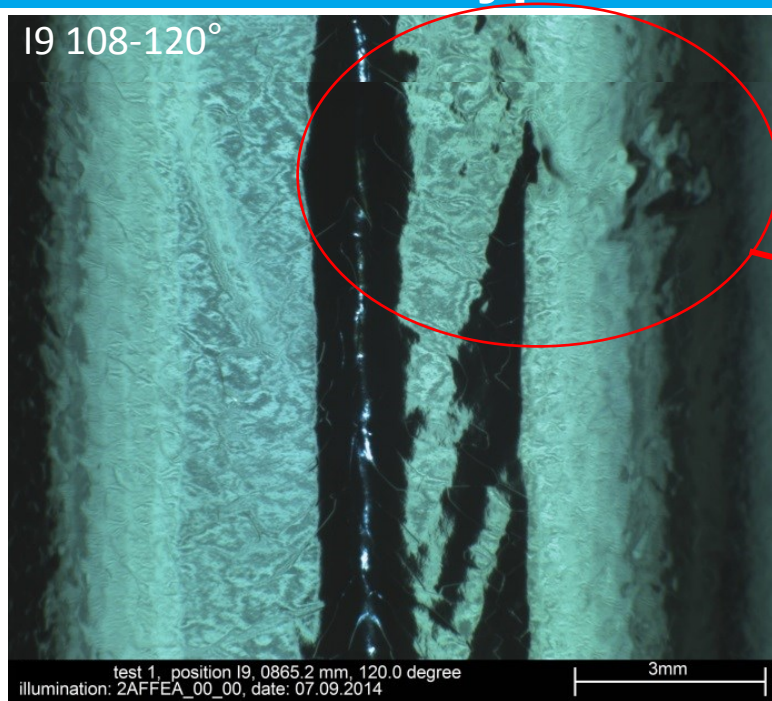
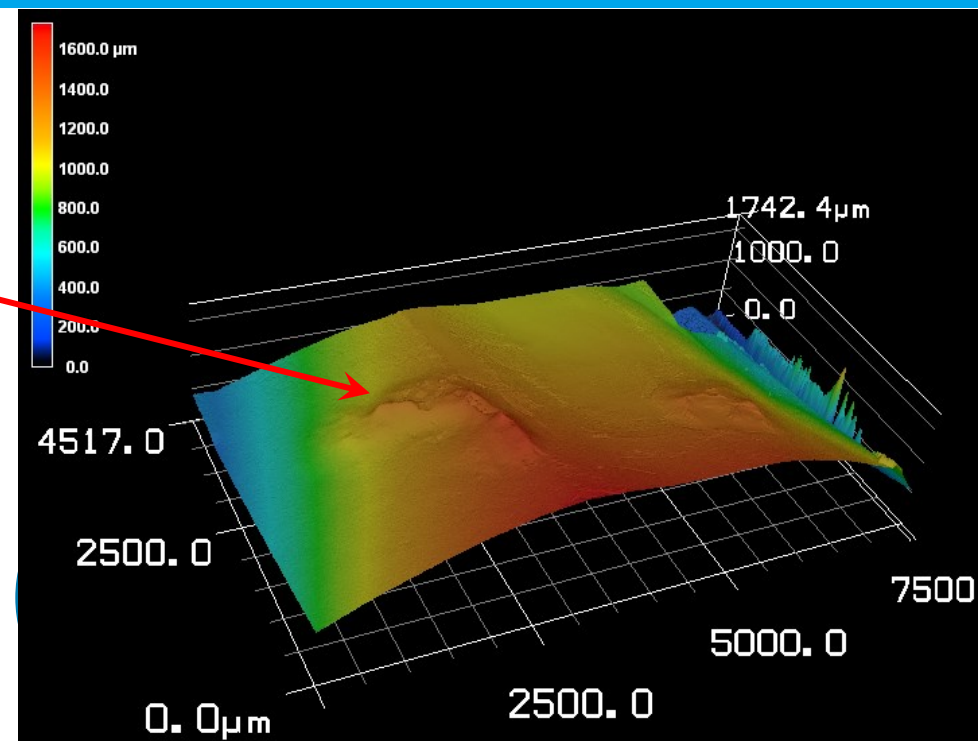
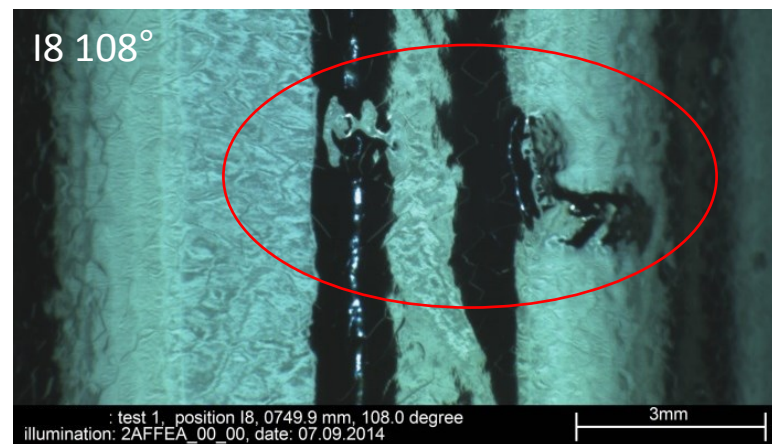
Typical surface defects: scratches

- > $E_{\text{acc,max}} = 23 \text{ MV/m}$, limited by quench with strong radiation, $E_{\text{acc,usable}} = 16 \text{ MV/m}$
- > Retreatment by add. HPR and 10 μm BCP did not improve the performance, made even worse
- > Several mm-wide protrusions with at least 100 μm height found on almost all irises at the same angle
- > Error: scratched by bent EP electrode

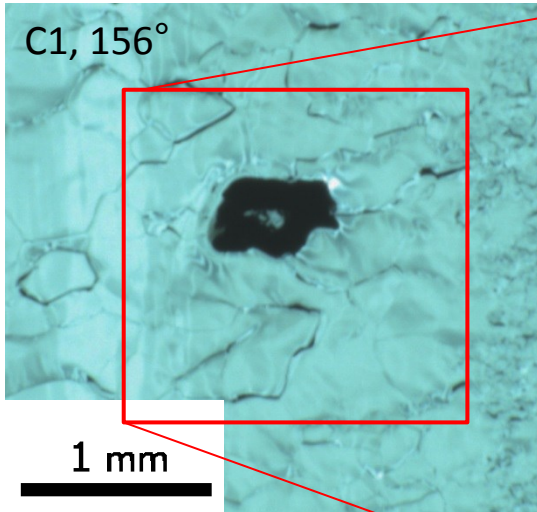
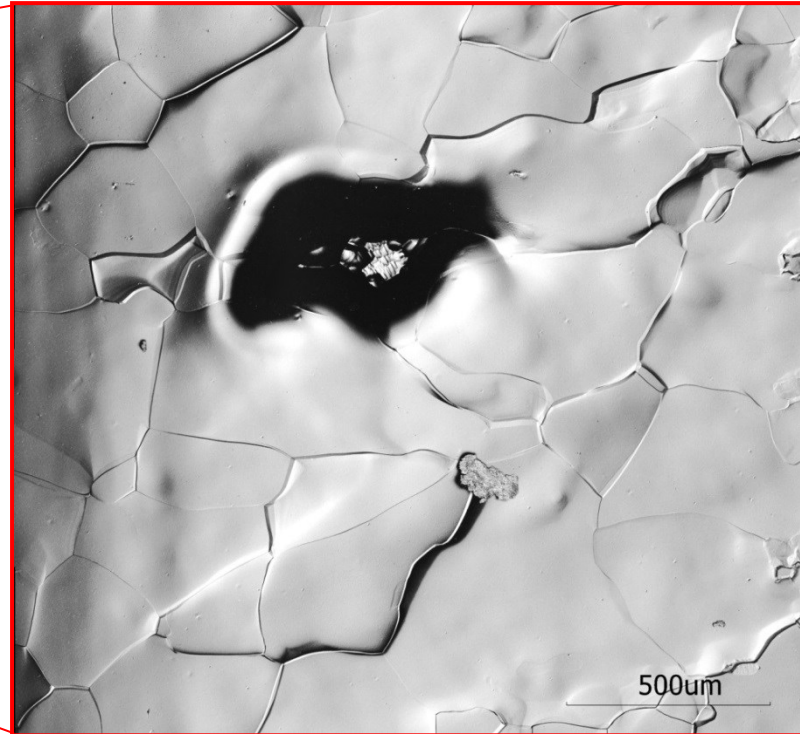
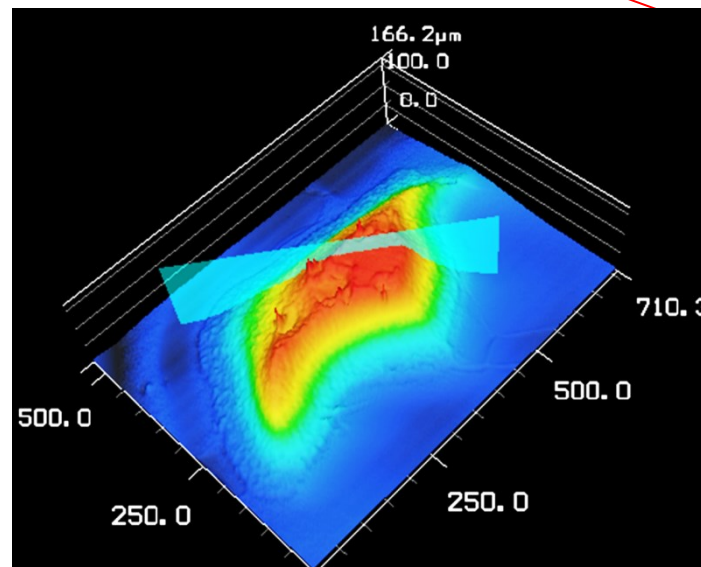
C1, 156°

- > $E_{\text{acc,max}} = 16 \text{ MV/m}$, limited by quench
- > Height of the defect is $\sim 124 \mu\text{m}$
- > Most probably a foreign inclusion not affected by polishing
- > No deviations seen on the initial Nb sheet
=> defect appeared during fabrication

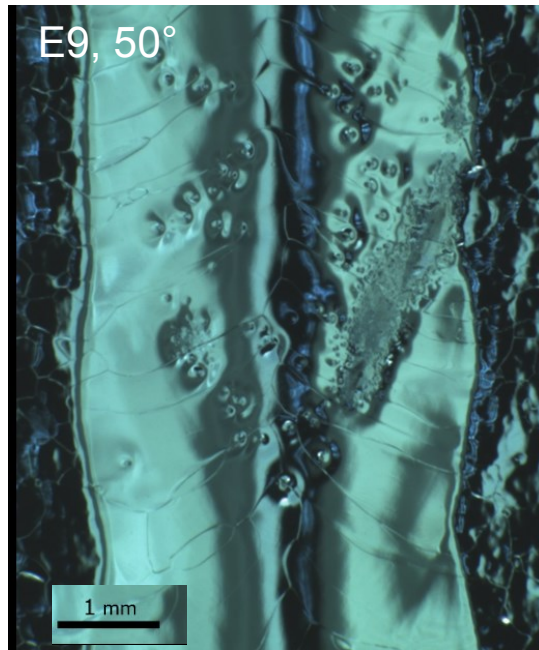
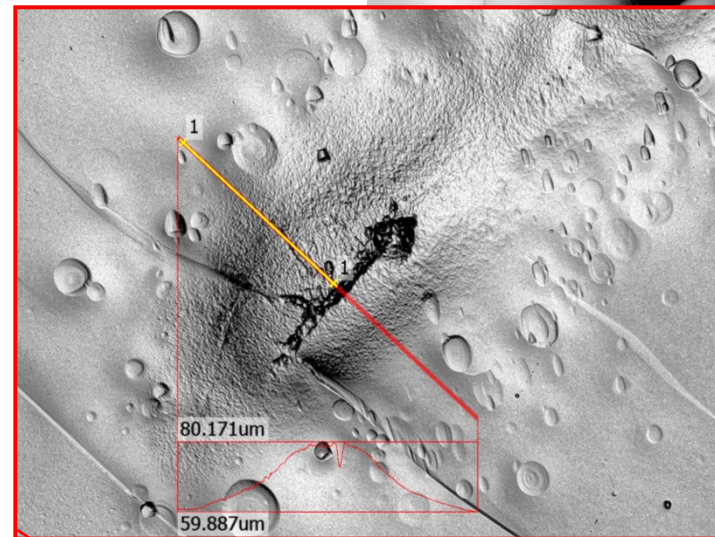
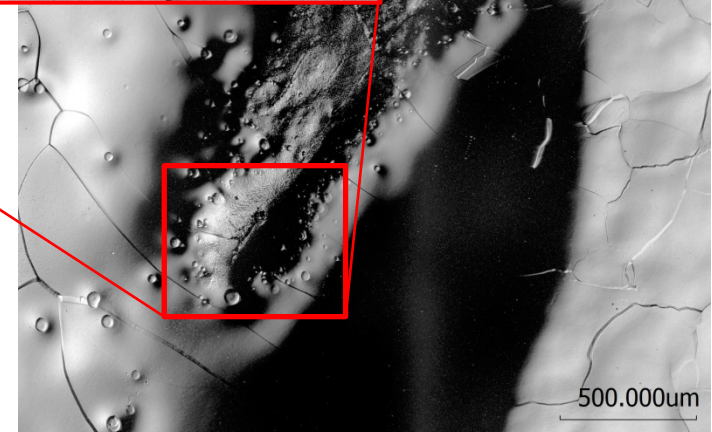
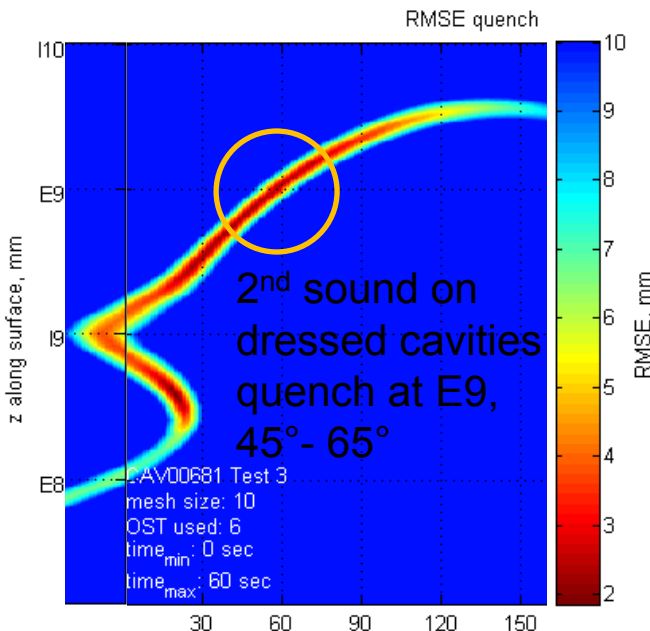
Typical surface defects: foreign inclusions

- $E_{acc,max} = 16 \text{ MV/m}$, limited by quench
- Etching defect due to contamination during welding
- Repair under discussion

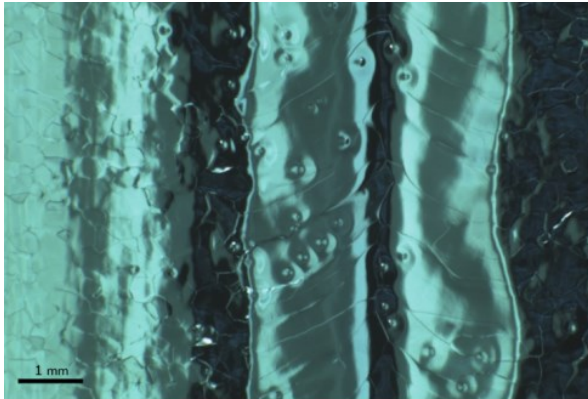
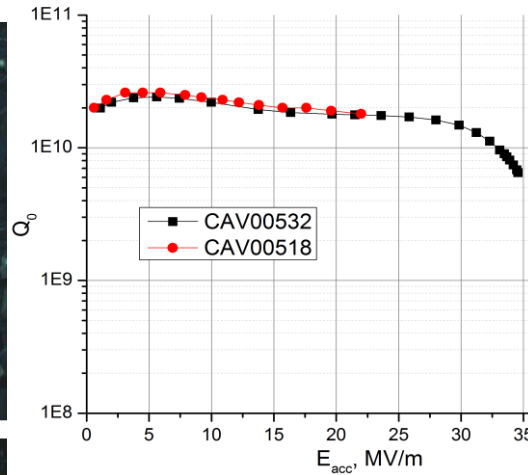
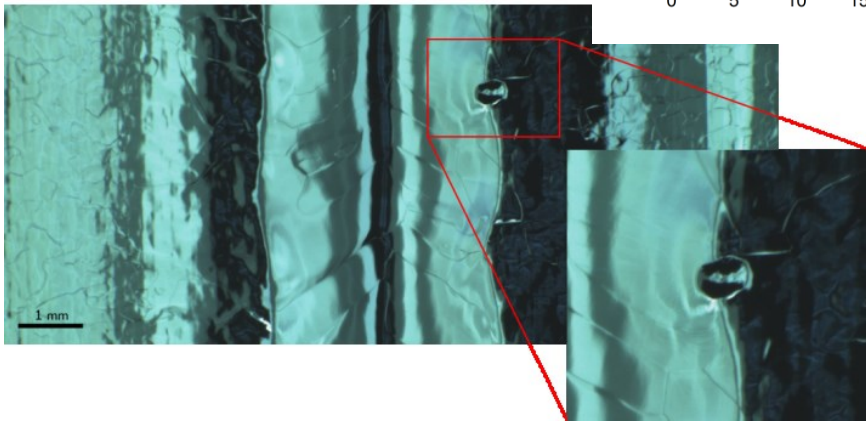
CAV00532:

→ **Successful** cold RF test result with **no FE**, RF power limited at 200W P_{in})

→ **Nice** RF result despite of “pits” and “cat-eyes” on the surface

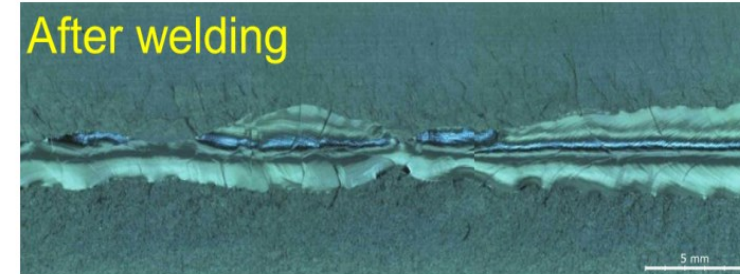
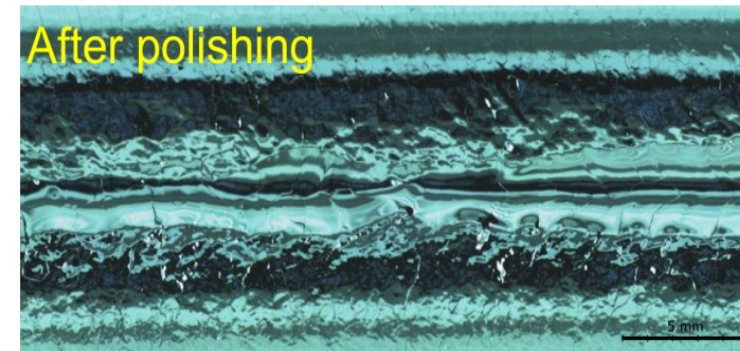
CAV00518:

→ Unsuccessful cold RF test result with quench at **22 MV/m**, **no FE**

→ OBACHT indicates defective welding as a possible quench reason

→ **“2nd Sound”** & **“T-mapping”** is applied for the quench localization and further studies

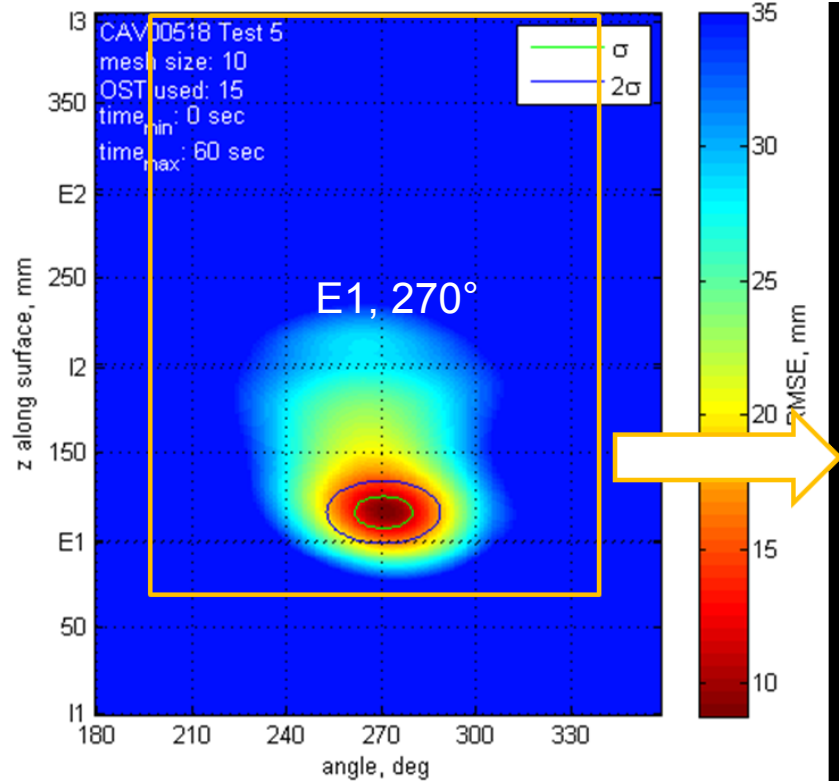
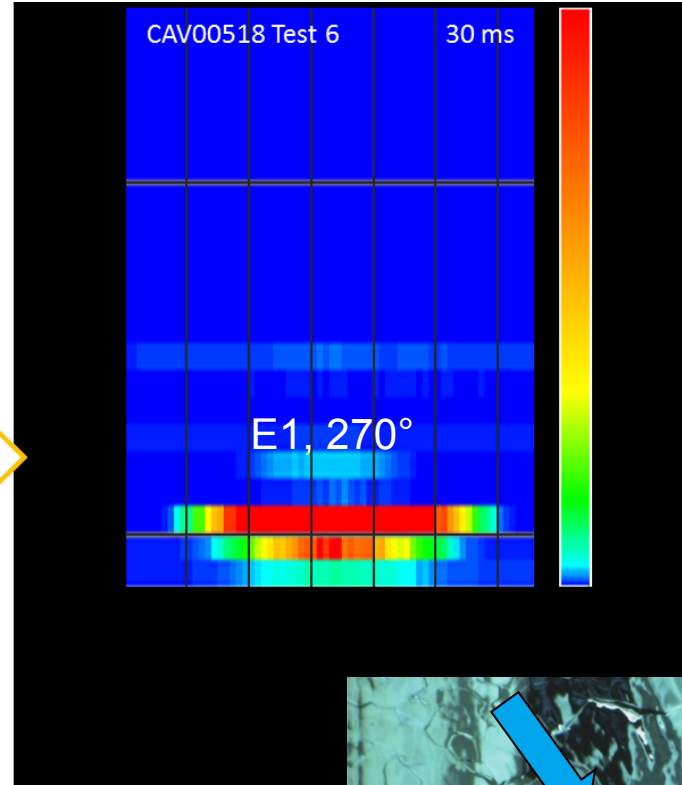
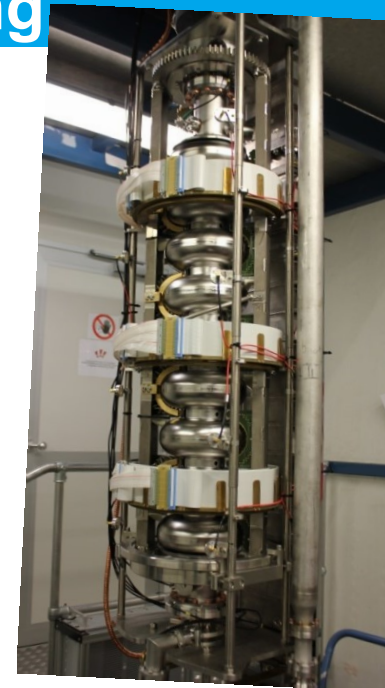
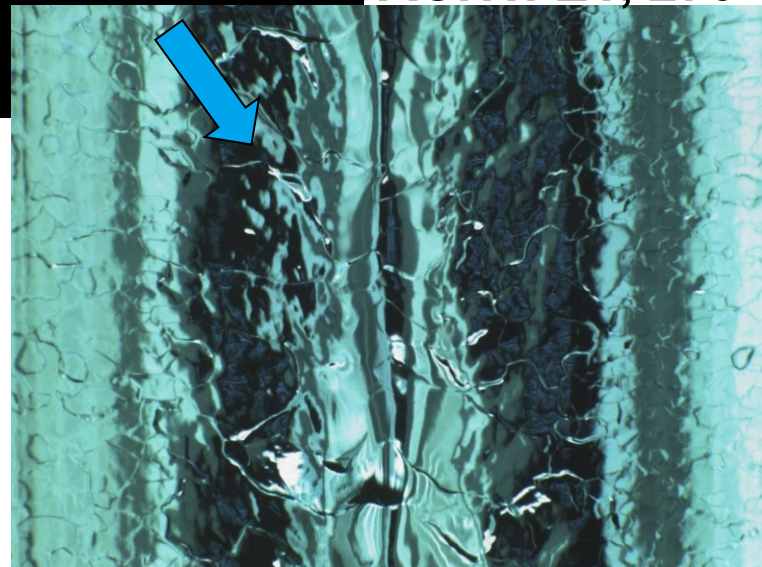
OBACHT: E1, 270°

- ⇒ Quench at 24MV/m, localized on the E1, 270°
- ⇒ **Good agreement** between T- and 2nd-sound mapping
- ⇒ OBACHT indicates **defective welding** as a possible quench reason

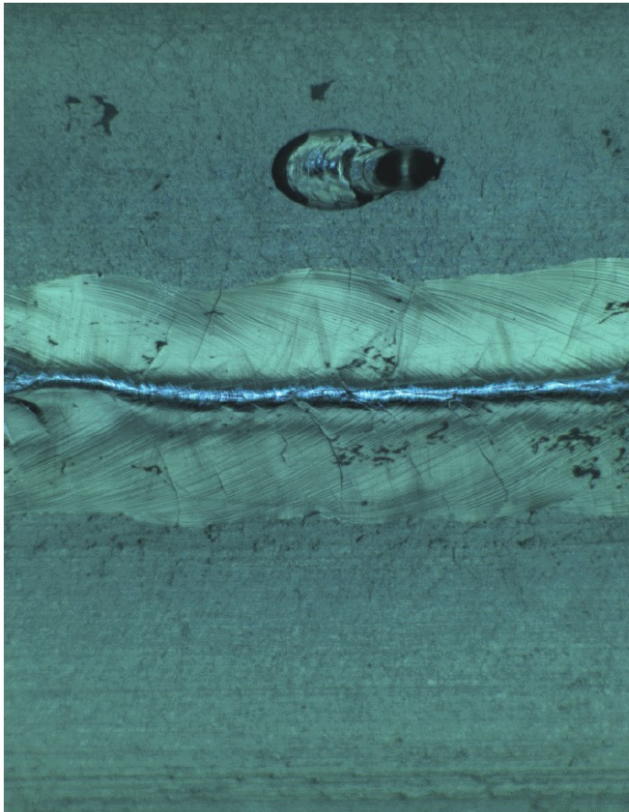
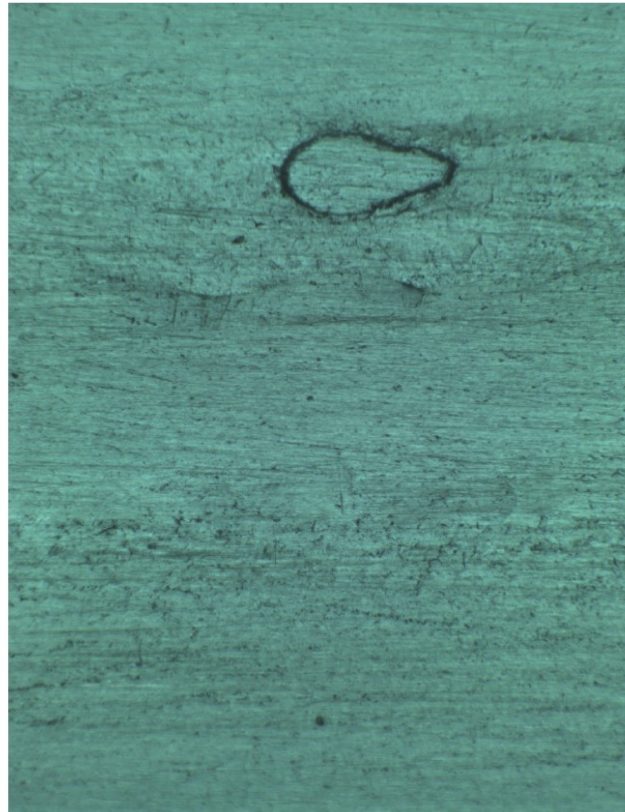
Typical surface defects: welding spatters

Endoscopes & OBACHT (shown here) inspections discover some “**spatters**” occasional occurring during the welding:

→ max $E_{\text{acc}} = 30.5 \text{ MV/m}$
→ no FE

- **reasons**: - blasts due to contamination
- sparks due to defective high voltage regulation of the electron beam welding machine
- an **additional grinding/repair** is required
- repair procedure using local grinder has been commission (manual one shown here)

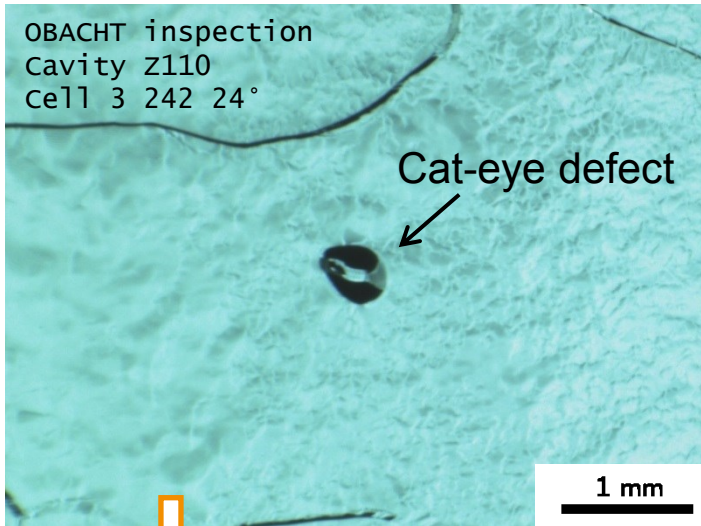
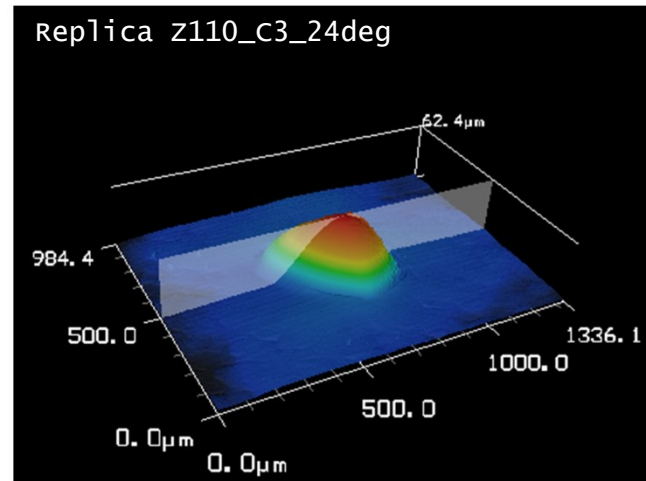
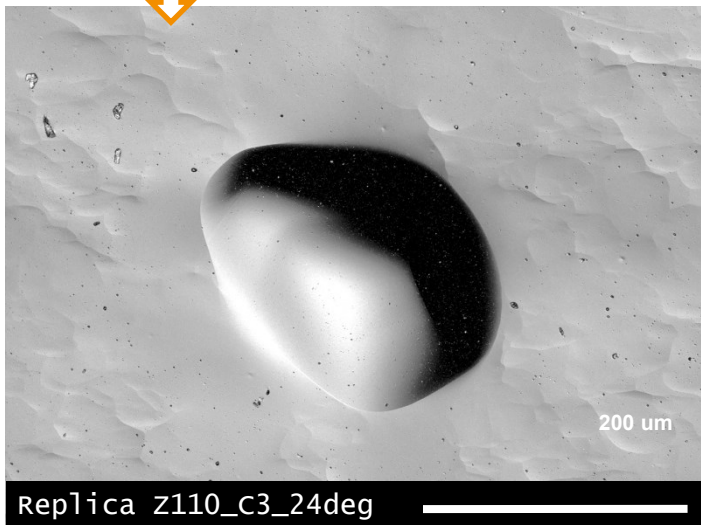
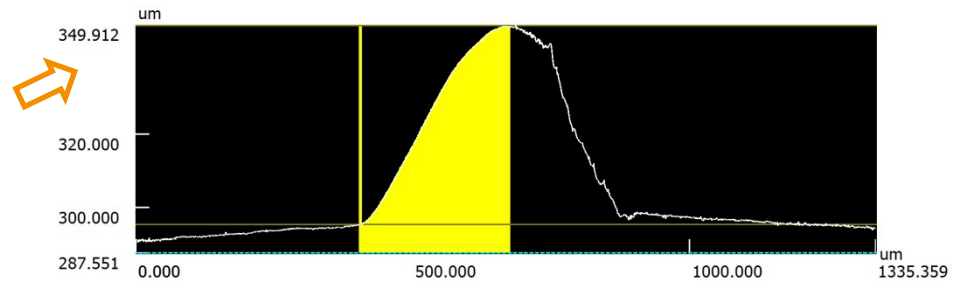
Replica: defects investigation

Pit in the surface. Depth 55 μm
