ILC-HiGrade cavities as a tool of quality control for the EXFEL and further SRF R&D

Aliaksandr Navitski *aliaksandr.navitski@desy.de

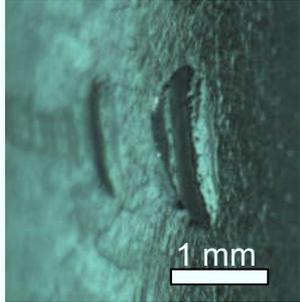
Scratches

=> **Handling failures:**

- ⊖ Strong x-ray radiation
- ⊖ Complicated repair required (tank removal, mechanical polishing inside cavities, and 2nd whole surface prepare pass)
- ⊕ Some failures identified and fixed

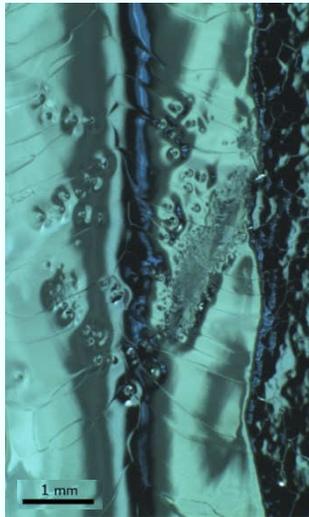
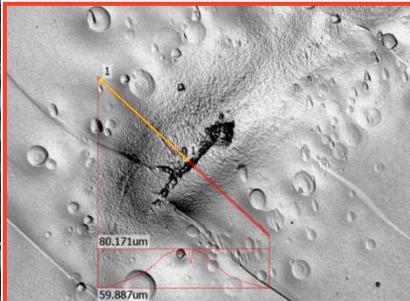
Pits or inclusions

=> Foreign material inclusions:

- ⊖ Low field quenches
- ⊖ Influence polishing process
- ⊖ Complicated repair required

“Etching pits”

=> **Etching effect (H₂ bubbles):**

- ⊕ No influence in high magnetic field regions (equators)
- ⊖ Might lead to radiation in high electric field regions (irises)

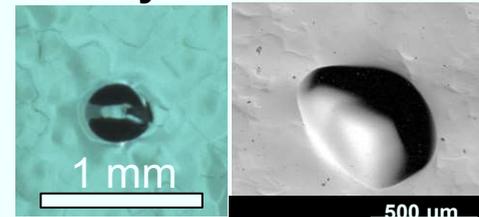
“Cat eyes”

- => **Voids in the surface**
- ⊕ Seems to be harmless
 - ⊕ No performance degradation observed

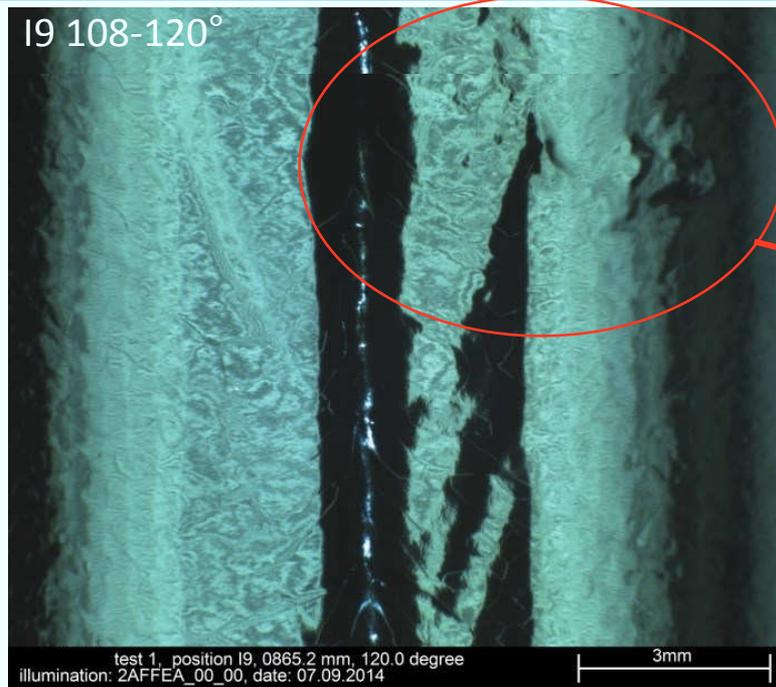
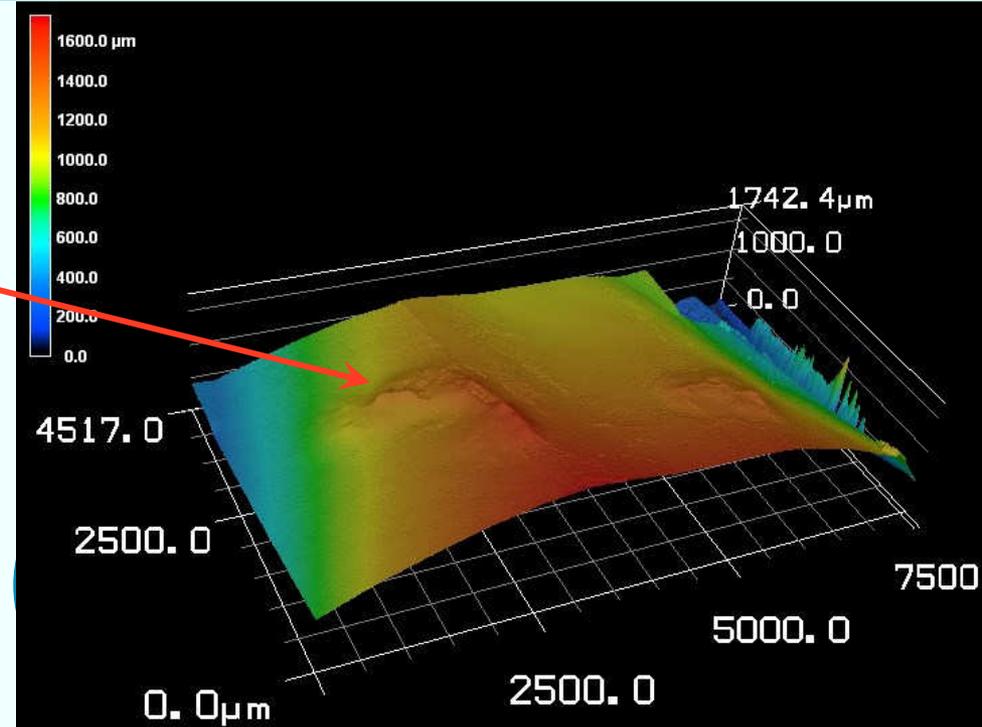
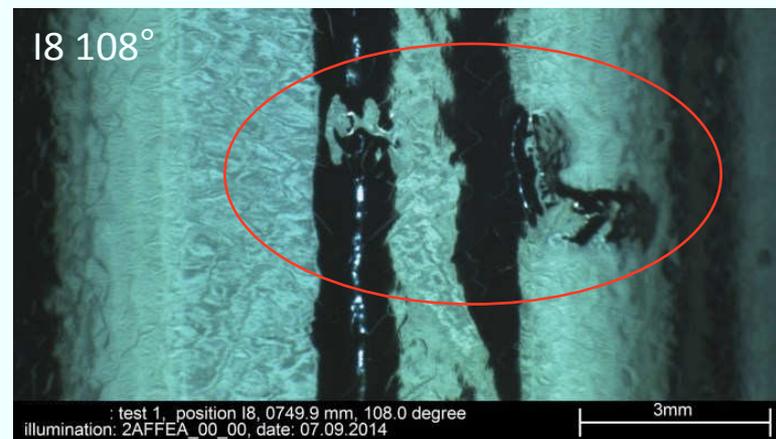
Typical surface defects: scratches

- > $E_{\text{acc,max}} = 23 \text{ MV/m}$, limited by quench with strong radiation, $E_{\text{acc,usable}} = 16 \text{ MV/m}$
- > Retreatment by add. HPR and $10 \mu\text{m}$ BCP did not improve the performance, made even worse
- > Several mm-wide protrusions with at least $100 \mu\text{m}$ height found on almost all irises at the same angle
- > Error: scratched by bent EP electrode

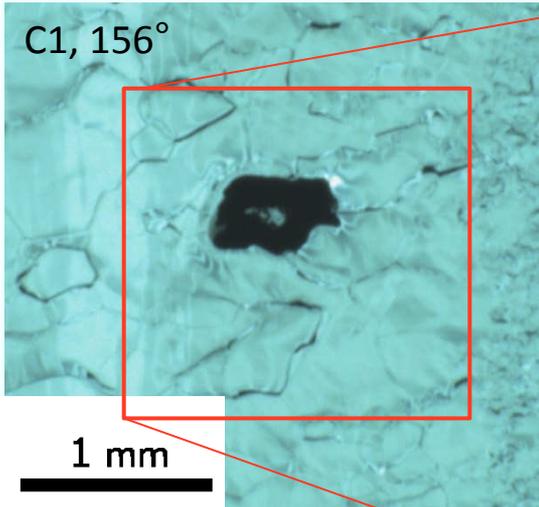
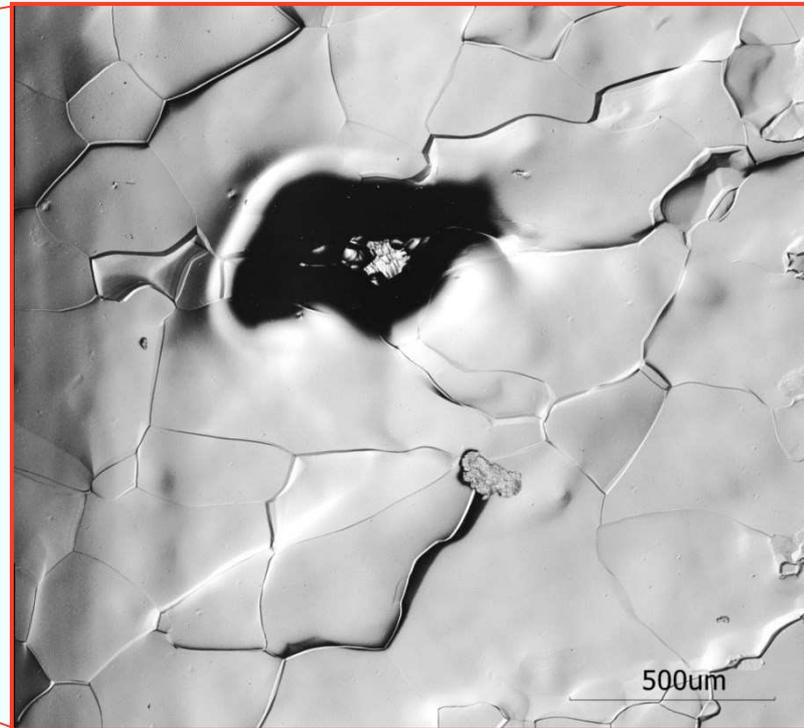
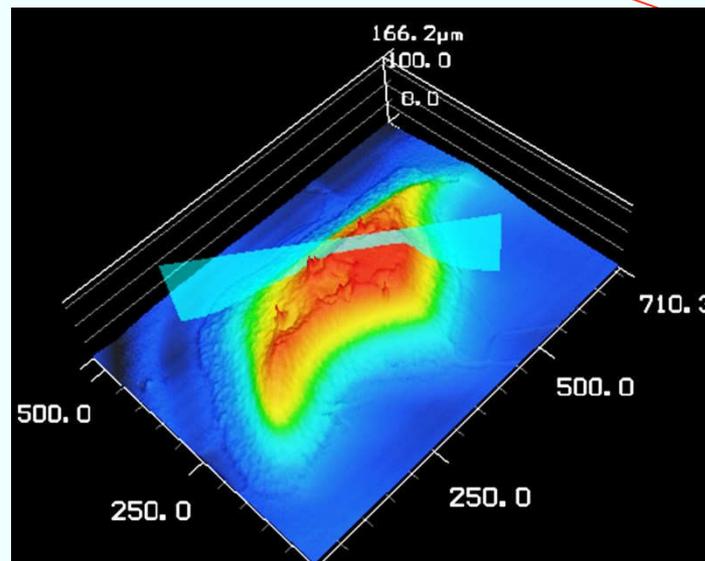
C1, 156°

- $E_{\text{acc,max}} = 16 \text{ MV/m}$, limited by quench
- Height of the defect is $\sim 124 \mu\text{m}$
- Most probably a foreign inclusion not affected by polishing
- No deviations seen on the initial Nb sheet
=> defect appeared during fabrication

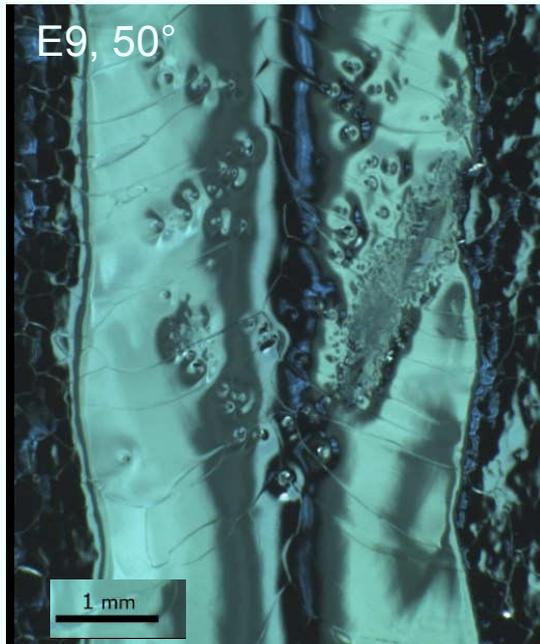
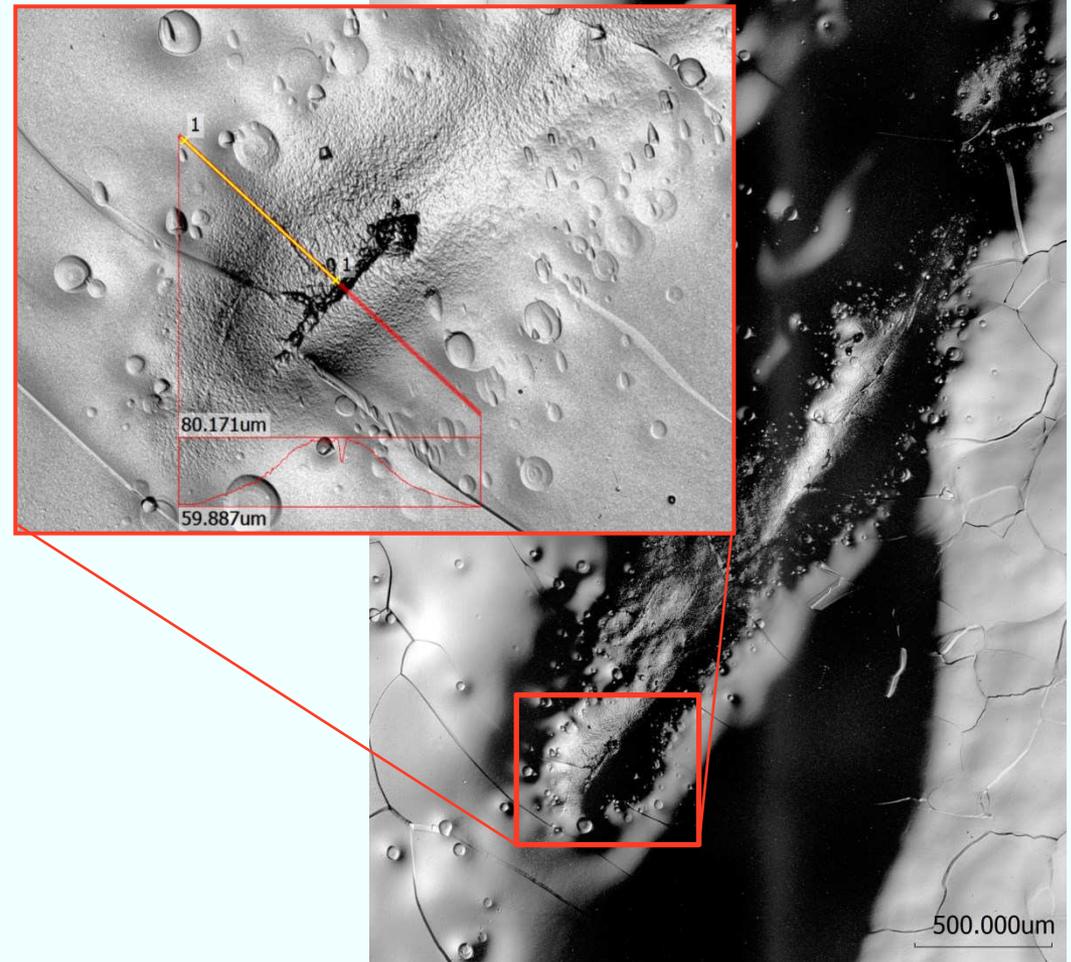
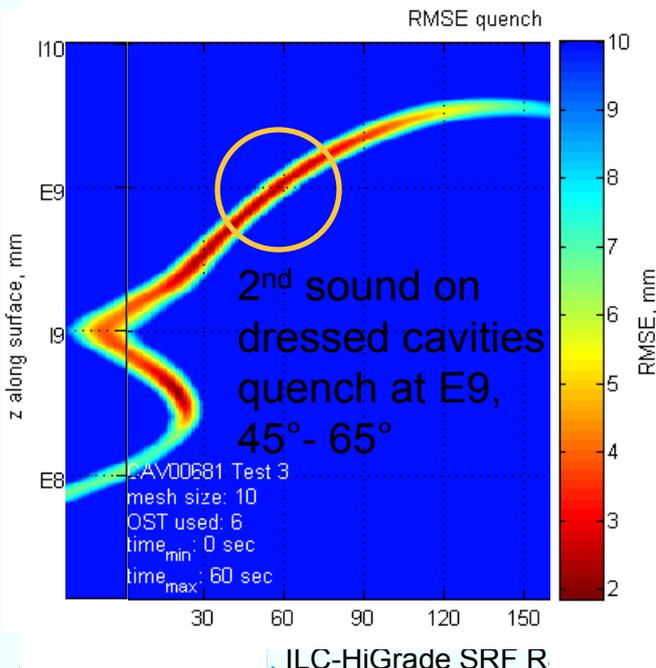
Typical surface defects: foreign inclusions

- $E_{acc,max} = 16 \text{ MV/m}$, limited by quench
- Etching defect due to contamination during welding
- Repair under discussion

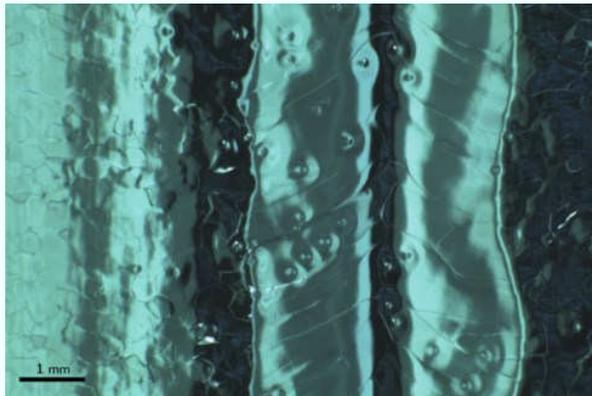
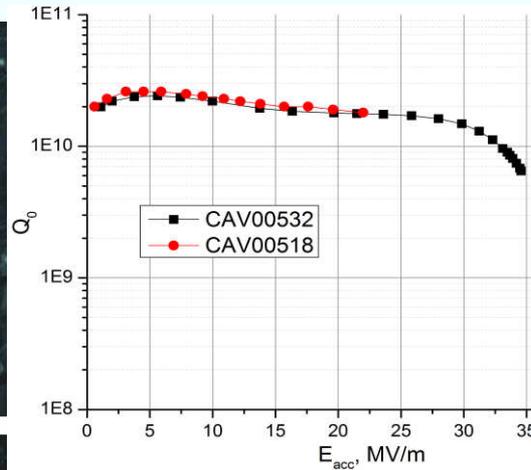
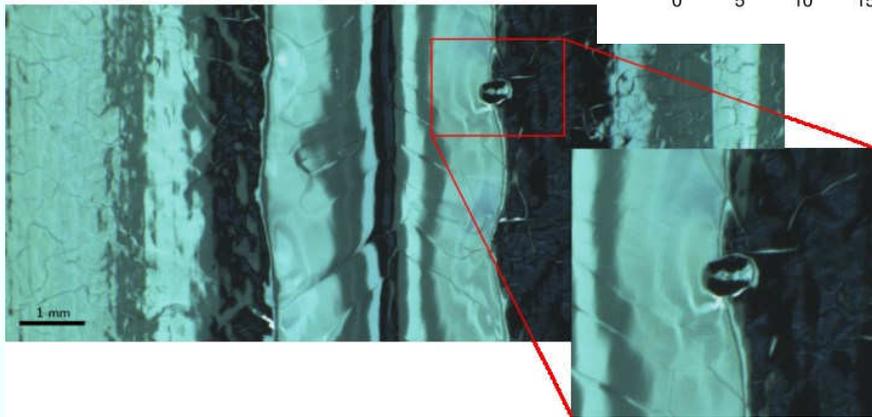
CAV00532:

→ **Successful** cold RF test result with **no FE**, RF power limited at 200W P_{in})

→ **Nice** RF result despite of “pits” and “cat-eyes” on the surface

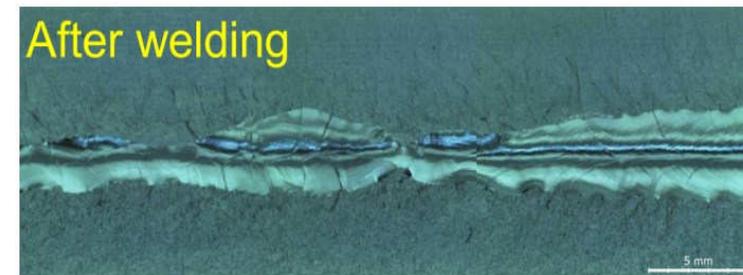
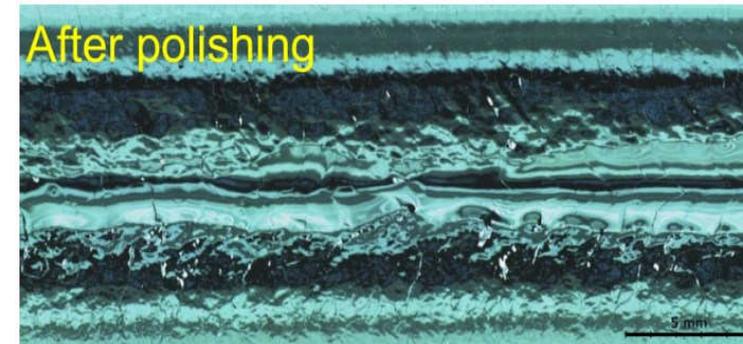
CAV00518:

→ Unsuccessful cold RF test result with quench at **22 MV/m**, **no FE**

→ OBACHT indicates defective welding as a possible quench reason

→ **“2nd Sound”** & **“T-mapping”** is applied for the quench localization and further studies

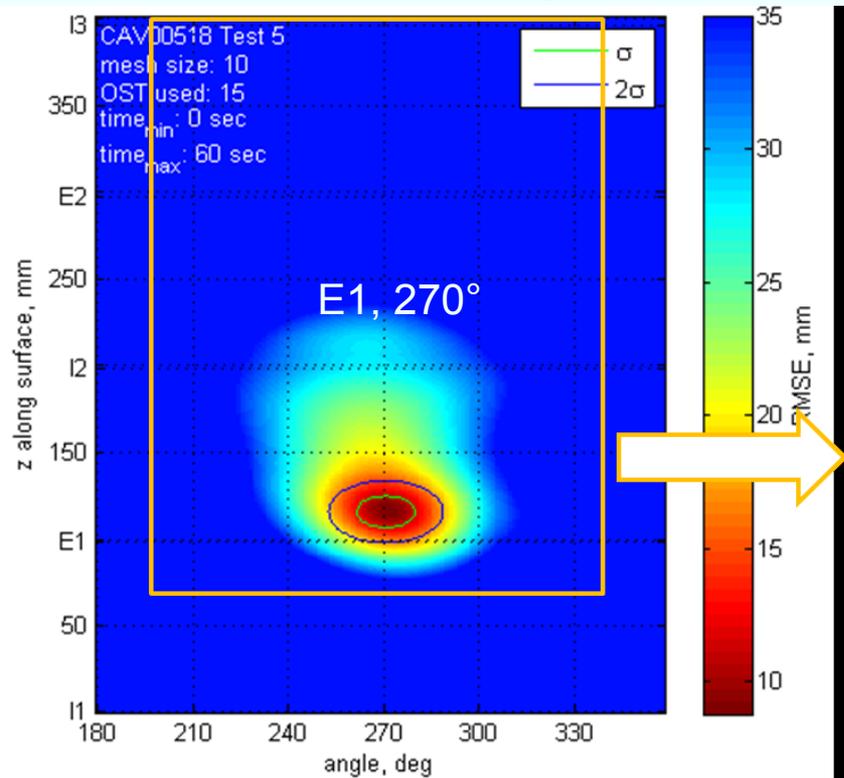
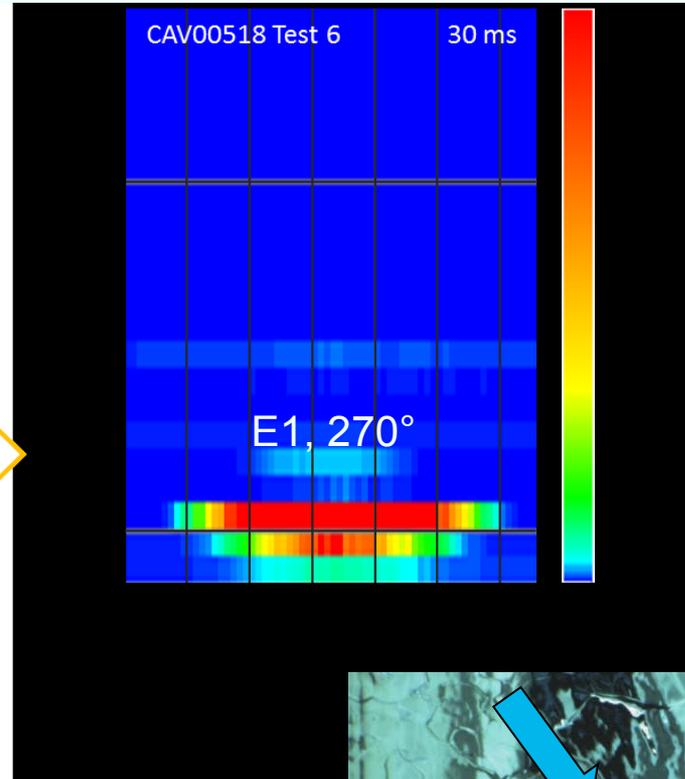
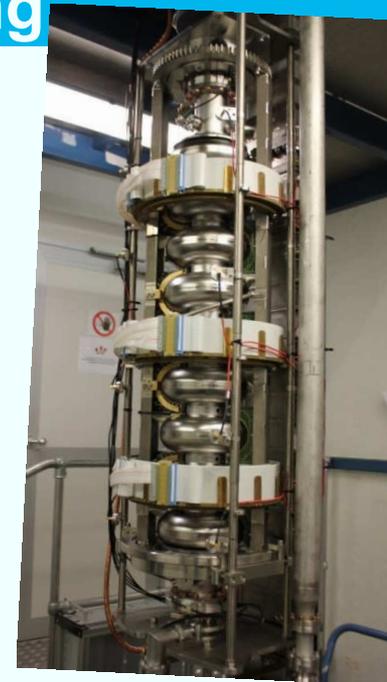
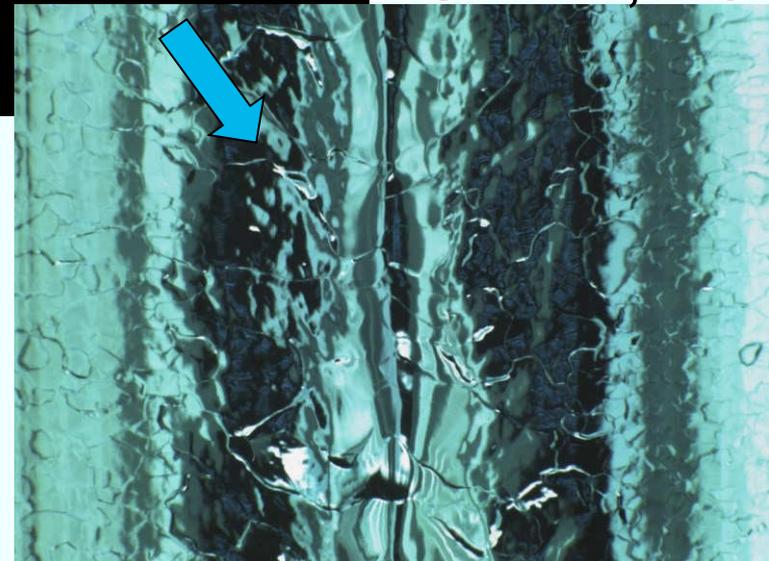
OBACHT: E1, 270°

- ⇒ Quench at 24MV/m, localized on the E1, 270°
- ⇒ **Good agreement** between T- and 2nd-sound mapping
- ⇒ OBACHT indicates **defective welding** as a possible quench reason

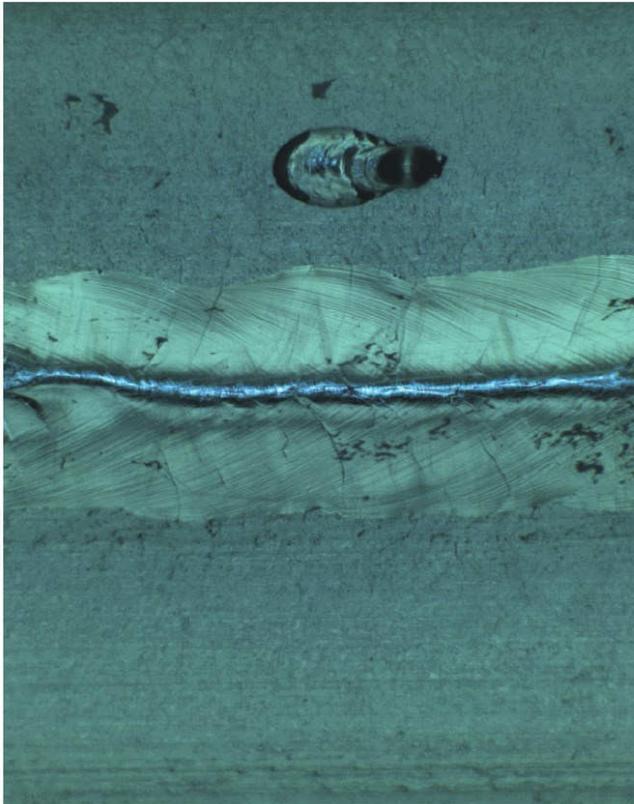
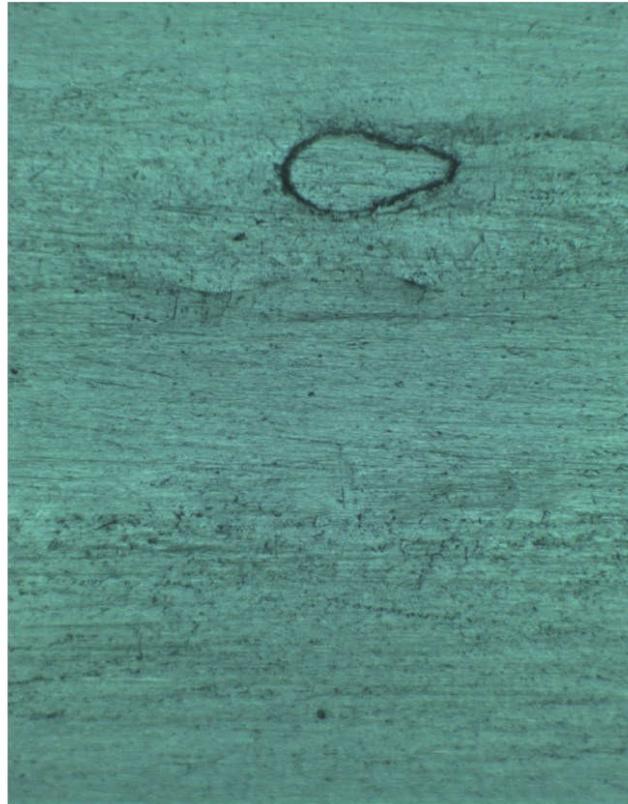
Typical surface defects: welding spatters

Endoscopes & OBACHT (shown here) inspections discover some “spatters” occasional occurring during the welding:

→ max $E_{acc} = 30.5 \text{ MV/m}$
→ no FE

- **reasons:** - blasts due to contamination
- sparks due to defective high voltage regulation of the electron beam welding machine
- an **additional grinding/repair** is required
- repair procedure using local grinder has been commission (manual one shown here)

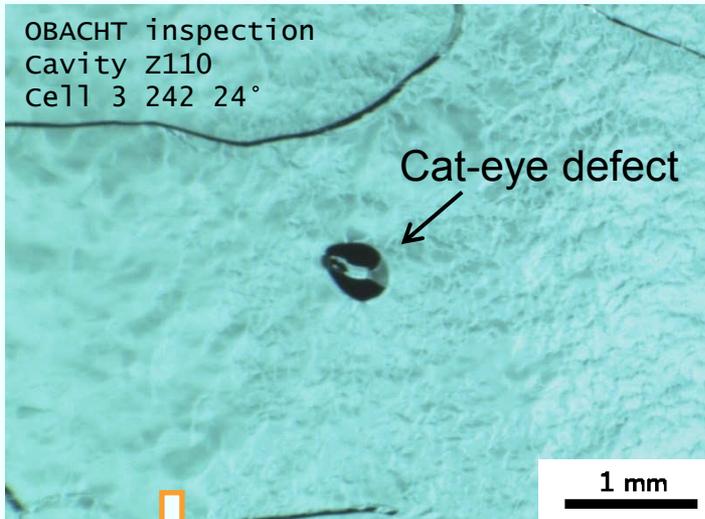
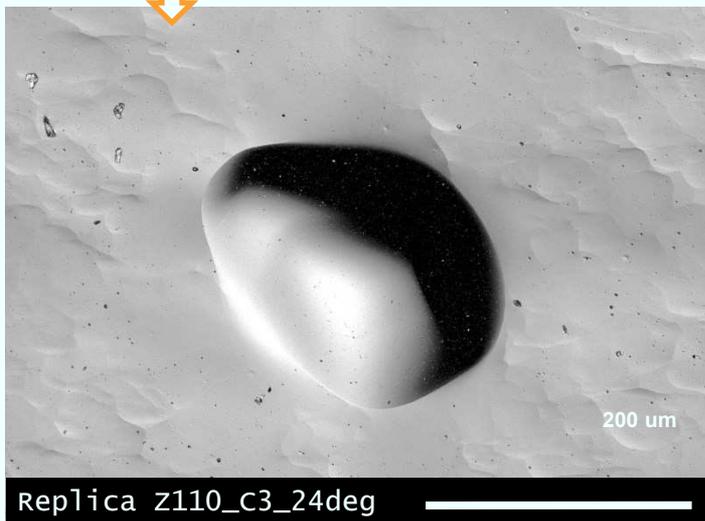
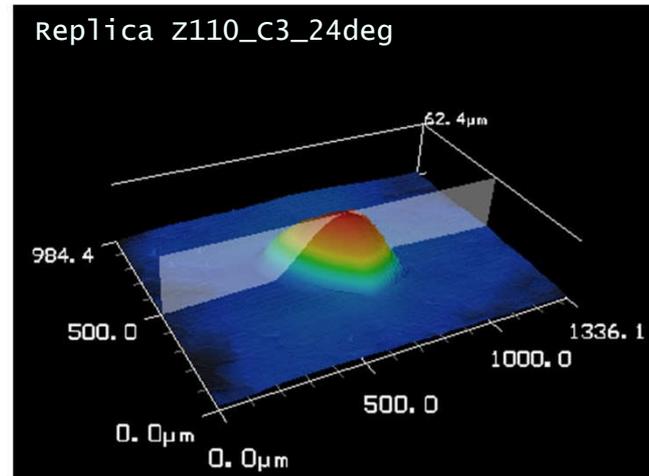
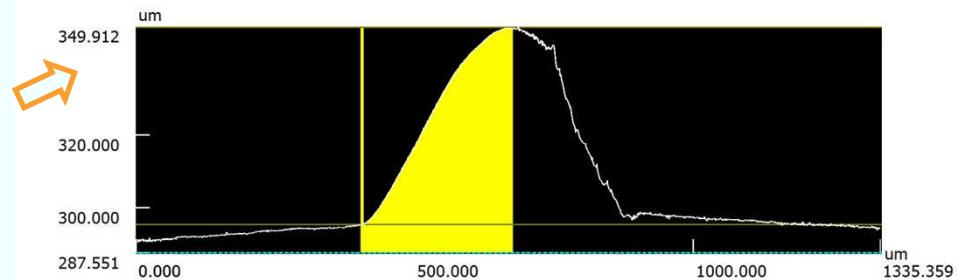
Replica: defects investigation

Pit in the surface. Depth 55 μm
