# RADIATION DAMAGE OF UNDULATORS AT PETRA III

P. Vagin\*, O. Bilani, A. Schöps, S. Tripathi, T. Vielitz, M. Tischer, DESY, Hamburg, Germany

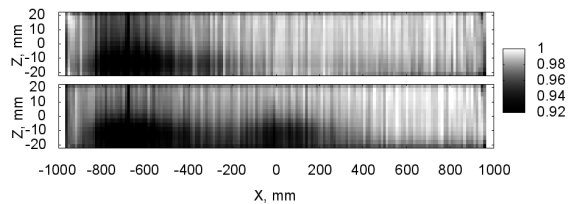
Figure 4: PU02 undulator demagnetization fieldmap measured for top and bottom modules separately at open gap.

During the current shutdown a few devices were removed from tunnel and properly remeasured in the lab. Measurements show a transverse non-uniformity of the demagnetization (higher field decrease at "ring-outside", negative Z), which is also different for top and bottom magnet modules (Fig. 3, 4). The demagnetization is highly localized longitudinally around X=-700mm and does not have its maximum

in the beginning. That would indicate a localized source of radiation, close to the undulator entrance, for example where the decreasing aperture of the vacuum chamber could cause additional beam losses.

The damage to the magnets is localized to the part which is close to the beam axis, therefore flipping of the magnets upside down could, for some time, fully correct field errors due to demagnetization, since the field contributions from the magnet parts far away from the beam axis is much lower.

For this particular device it was decided to refurbish the magnets. The magnets will be remagnetized, the coercivity will be enhanced by a rare earth diffusion process to strengthen the grain boundaries and after all an additional coating will be applied to prevent them from corrosion by exposure to synchrotron radiation.

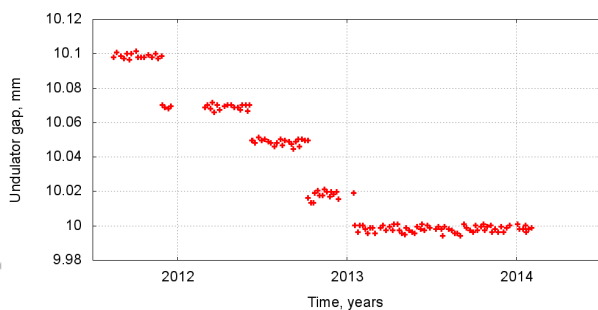
Figure 5: PU02 gap setting to reach 60keV on 7<sup>th</sup> harmonic is decreasing over time to compensate demagnetization, till it reaches minimum gap defined by vacuum chamber size.

In order to compensate for the demagnetization of the PU02 undulator, gap settings to reach the same wavelength were decreasing over time until reaching the minimum value defined by vacuum chamber. Therefore it was decided to refurbish the magnets during current one-year shutdown for building PETRA III Extension. After that, further improvements in beam lifetime and more careful machine operation should reduce beam losses and therefore radiation damage to the insertion devices.

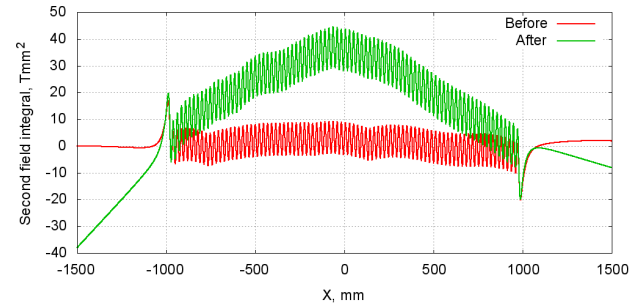
Despite the strong field losses of ~6%, the trajectory straightness was not really affected, as a significant number of poles were demagnetized. Thus field changes on neighbouring poles with opposite signs were similar, having only minor impact on field integrals (Fig. 6).

Figure 6: PU02 trajectory before and after demagnetization.
