# Refurbishment of Radiation-Damaged Undulators

*Deutsches Elektronen-Synchrotron DESY, Notkestr. 85, 22607 Hamburg, Germany*

**Abstract.** Partial radiation damage has been observed over the previous five years of operation for a few of the PETRA III permanent magnet undulators at DESY. The degradation of the affected devices has been observed by a change in the energy tuning curves and the spectral properties of the undulator harmonics, and also by direct measurements of the peak field distribution of the magnet structure in the storage ring tunnel [1]. During the recent shutdown of the machine, two undulators were removed from the tunnel for repair. One of the devices (U29) has been retuned after flipping of all magnets of the hybrid structure. In addition to this temporary repair, one further magnet structure (U23) has been completely disassembled and refurbished by application of a rare earth diffusion process and a coating to the permanent magnets. We will report on the details of the refurbishment of these undulators which were both fully brought back to specifications and are meanwhile back in operation.

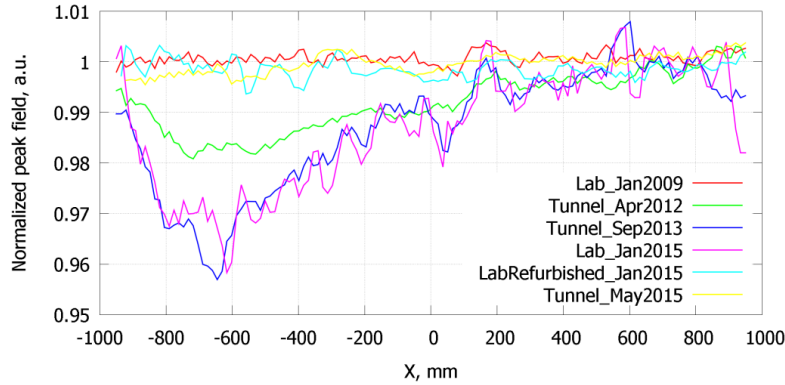
The undulator U29 at the PETRA beamline P08 is a 2 m long device with 29 mm period length. It is the first device which was installed at PETRA III and is in operation since the beginning of 2009. As reported previously [7], the undulator shows signs of spectral degradation for already several years. The long shutdown of PETRA III in 2014 was the first opportunity to take out the undulator from the tunnel for inspection and repair in the magnet lab. The magnet structure was at first remeasured in the damaged state to correlate these data to the initial measurements and to measurements in the storage ring tunnel, where the magnetic peak field was checked by a simple appliance several times over the recent years. Fig.1 shows a comparison of these data and illustrates the demagnetization increase over time. It is clearly visible that the magnet structure is mainly damaged close to its upstream end and

experienced a peakfield loss of up to 4%. The demagnetization pattern builds up after the first few periods and reaches a maximum about 35 cm behind the undulator entrance before it slowly decays towards the downstream end of the device. PU08 is the upstream ID in a canted straight, the PU08 entrance therefore corresponds to a location with the tightest e-beam aperture. The aperture jump from the circular vacuum chamber of the adjacent upstream quadrupole magnet to the elliptical ID-chamber happens in a vertical taper section located 40 cm before the undulator entrance; this suggests that a distance of approximately 75 cm is passed until the radiation shower from scattered and then lost particles has developed its full impact. From the temporal development of the demagnetization profile in Fig.1, it can also be seen that the damage has not been caused by a single incident during the initial commissioning phase of the storage ring but has continuously built up over time; this is qualitatively also confirmed by thermo-luminescent dosimeters which are regularly read out as a long-term survey of all the ID straight sections.

**FIGURE 1.** Temporal development of the demagnetization of undulator U29, which is the upstream device in a canted straight section. The measurements were done on-axis ( $z=0$ mm), the electron beam enters from the left side.

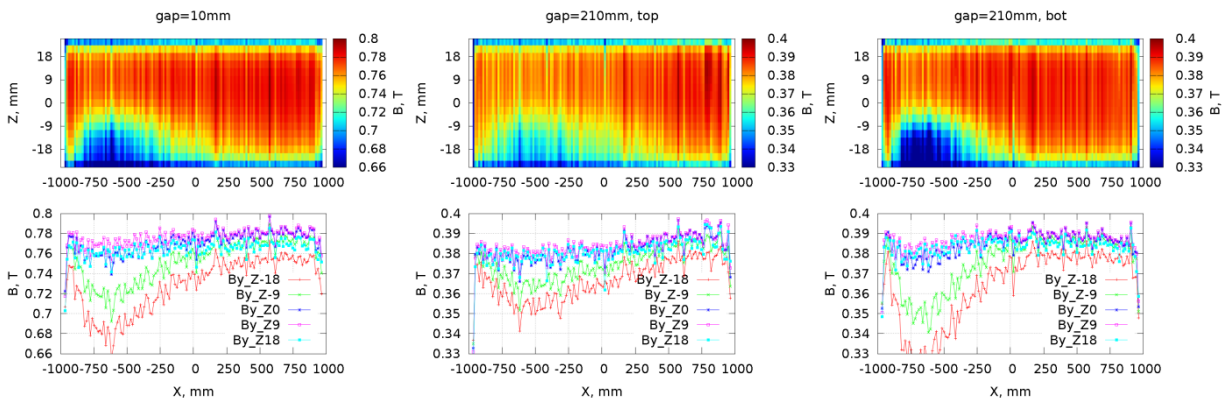
Figure 2 shows a spatial 2D field map of the magnet structure measured after removal of the undulator from the storage ring. The demagnetization patch at the upstream side of the structure is very prominent and also two other asymmetries are clearly visible: In the affected area, the magnet structure is damaged more at the bottom side and predominantly at the ring-outside part. The same spatial pattern is observed as for the damaged 23 mm period length (U23) undulator [1] which is located at an equivalent lattice position in the storage ring. There is up to now no clear understanding for either of the two aspects. While a vertical asymmetry in demagnetization could be explained by a systematic vertical orbit displacement with respect to the ID chamber center, such an effect cannot account for a transverse displacement of the hot spot by 20 mm or more.

**FIGURE 2.** 2D-fieldmap (top) of the U29 magnet structure and field profile along the structure at different transverse  $z$ -positions (bottom), at closed gap, and separately for bottom and top magnet girder, measured at open gap (negative  $z$ -values correspond to ring outside, beam entrance at negative  $x$ -values).

Flipping of magnets upside down was applied in order to reestablish the old field level. This approach has been successfully used in the past for repair of several radiation-damaged undulator magnet structures at APS [8]. A beforehand flip test of several single magnets proved that the original field strength could be restored. It was, however, observed that also the magnets of the downstream part of the structure were slightly demagnetized as flipping enhanced the field by  $\sim 0.02\text{T}$  (2.6%). From the fieldmap in Fig.2 it can be seen that the damage in the downstream part is more uniform.

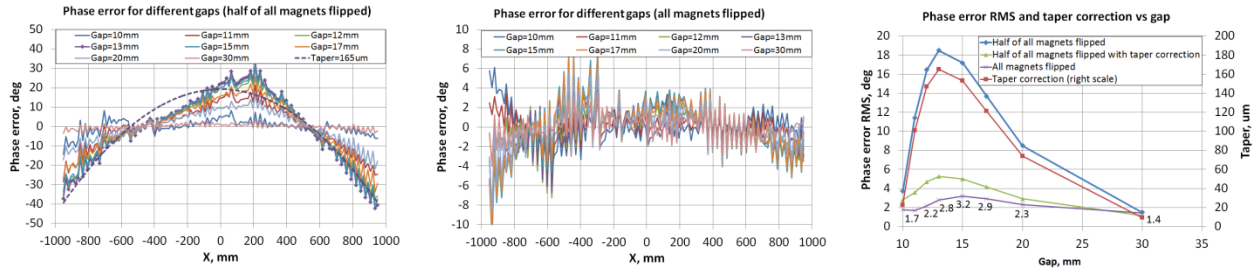
**FIGURE 3.** Phase error of U29 at an intermediate repair state where magnets had only partially been flipped (left); large gap dependent errors remained (right). Only after complete flipping of all magnets, small phase errors could be obtained (center).

As an initial attempt for repair, all top and bottom magnets in the longitudinal subrange  $-1000\dots+200\text{ mm}$  had been flipped upside down. After several tuning iterations, a reasonable phase and trajectory error at closed gap could be achieved on-axis although some transverse effects remained. Although the trajectory was completely straight over the entire gap range, a strong gap dependence in the phase error (Fig.3) was obtained exactly at the transition from flipped to non-flipped magnets (around  $x\sim 200\text{ mm}$ ). This effect can be attributed to a  $\sim 100\mu\text{m}$  step in the vertical pole position at this location introduced by tuning in order to obtain the same  $K$ -value and phase advance in the remaining part of the structure where magnets had not been flipped. Thus, a slightly different gap dependence of the  $K$ -value in the two different regions of the magnet structure resulted in a piecewise linear, i.e. nearly perfect, phase error where the different slopes correspond to slightly different emitted wavelengths. By means of a longitudinal taper as a feed forward correction, the remaining phase error could be improved by a factor of  $\sim 3$  (Fig.3).

Nevertheless, the overall performance of this undulator was not yet regarded as satisfying, and finally all remaining magnets had also been flipped upside down. In this configuration, the undulator could easily be tuned back to specs with a remaining phase error of  $1.4^\circ\dots 3.2^\circ$  rms in the entire gap range. The maximum  $K$ -value of the device could even be enhanced by  $\sim 6\%$  because a pole-overhang into the gap could be removed which was initially required for application of magnetic shims. In contrast to the positive experience at APS where magnetic tuning is mostly done by application of shims, an only partial flipping of magnets may lead to magnetic artefacts for a virtual shimming by pole height adjustment.
