# ACCELERATOR MODULE REPAIR FOR THE EUROPEAN XFEL INSTALLATION

E. Vogel, S. Barbanotti, F. Hoffmann, K. Jensch, D. Kostin, L. Lilje,  
W.-D. Moeller, M. Schmoekel, H. Weise, DESY, Hamburg, Germany  
S. Berry, O. Napoly, CEA, Irfu, DACM, Centre de Saclay, France  
M. Sienkiewicz, J. Swierblewski, M. Wiencek, IFJ PAN, Krakow, Poland

Repair actions of different extent have been performed at 61 of the 100 accelerating series modules for the European XFEL to qualify them for tunnel installation. Four modules could not be repaired in time. CEA Saclay managed to perform three major repairs in parallel to the series module integration, the residual repair actions took place at DESY Hamburg. In this paper we will give an overview on the various technical problems which required being fixed before the tunnel installation and on the repair actions performed.

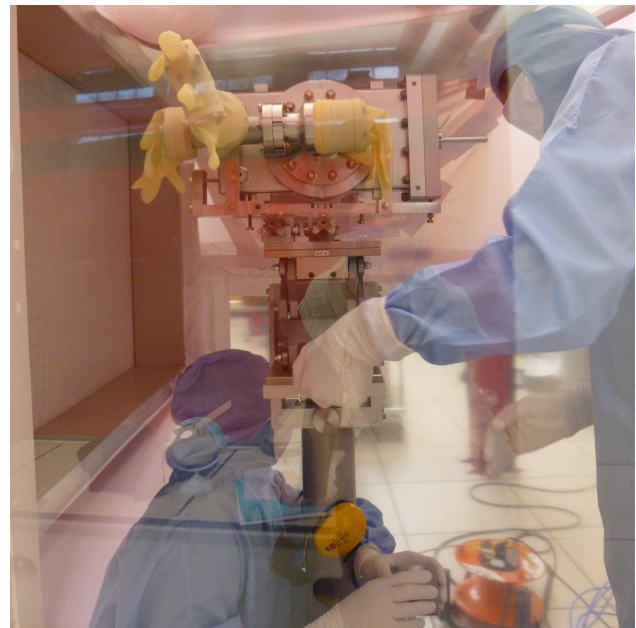
After the incoming inspection and the survey check have been performed at the AMTF, the upstream gate valve of XM54 was found defective. Normally the module required a disassembly and the complete string entering a clean room. This was incompatible with the module production running at full speed due to the blocking of workstations and personnel needed elsewhere. For almost one year XM54 was put aside and solutions were evaluated. Then the module was brought to CEA and disassembled with the string still hanging under the cold mass in front of the clean room. The support used for the gate valve assembly inside the clean room was moved on the rail system outside the clean room

Figure 3: Locan clean room with horizontal laminar flow used for the exchnage of the defective gate valve of XM54.

and a local cleanroom with horizontal laminar flow installed around the upstream end of the module including the gate valve and the support (Fig. 3). The gate valve exchange was controlled by a particle counter. After re-assembly the module has been tested at the AMTF for the first time. The performance of the first cavity is degraded by field emission; all other cavities kept their performance above the (administrative) RF power limitation at 31 MV/m. The module provides an average usable gradient of 30.1 MV/m and is installed in the tunnel.

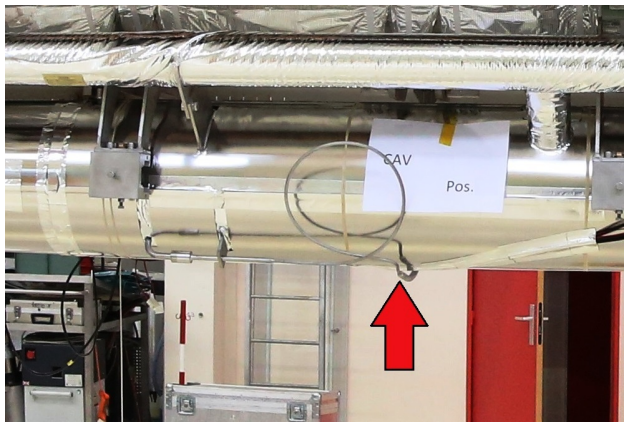
XM8 has been assembled at CEA in spring 2014, when the module assembly was still in the ramp up phase. Nevertheless, the 2 K circuit consisting of the 2-phase pipe itself, the warm-up cool-down line and the cavity tanks was never suspicious-looking for any leaks. Connecting the module to the AMTF test stand two leaks appeared. One in the bellows of the coupler 5 push rod and one at the 2 K circuit with a leak rate of  $8 \cdot 10^{-8} \frac{\text{mbar l}}{\text{s}}$ . In situ exchange of the coupler push rod bellows cured the coupler leak. Separating the process lines to enclose the area where the leak is located revealed the leak location somewhere at 2-phase line and warm up pipe. In October 2014 the module was removed from the test stand without cold test, wrapped to guaranty low humidity and put aside for later investigation and repair as personnel was tight during the ramp up phase. In October 2015 the module has been brought to "Halle 3" for further investigations. Motivated by the experience with leaks at the magnet current leads of XM21 the magnet current leads were examined first without finding a leak in this area. Then XM8 was disassembled to make the 2 K circuit accessible. The leak was found at the capillary on the warm-up cool-down pipe connection at cavity 6 (Fig. 4). The weld was repaired and the following leak check at warm showed no anomalies. The repair took 38 days. In March 2016 the cold test resulted in an average usable gradient of 26.3 MV/m. After the warm up a  $10^{-9} \frac{\text{mbar l}}{\text{s}}$  leak has been found again in the 2 K area. The module was put aside for further investigation, presently still ongoing.

Figure 4: Position of the leak at the XM8 Helium filling line. The photograph shown here was taken at a different module at the CEA assembly line.

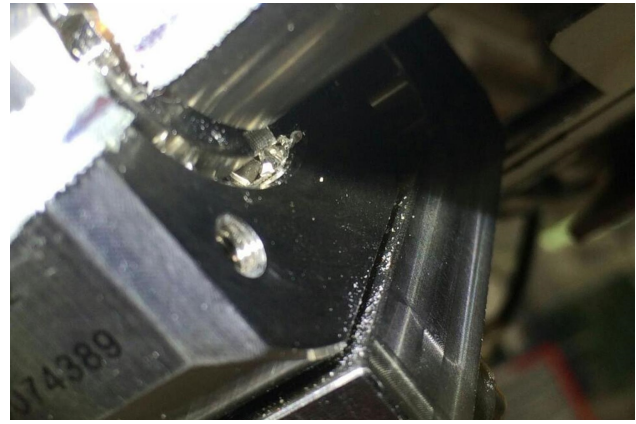
Different problems arose while testing the module XM93: two helium leaks appeared at the 2 K and 70 K area respec-

Figure 5: Multi-layer insulation trapped in the XM93 ball bearing of the tuner motor.

tively and cavity 1 could not reach its nominal frequency of 1.3 GHz nor go back to its nominal warm up position once the module was cold. All the problems were solved without disassembling the module; the leaks required some re-welding of the end pipe connections outside the module, while the frequency tuning problem needed some part exchange: the optical inspection performed after warm up revealed multi-layer insulation (from the test stand) trapped in the ball bearing of the tuner motor (Fig. 5). The drive unit was exchanged and the tuner performances measured to verify the results of the repair work. The frequency change operating the tuner motor was within the acceptance values.

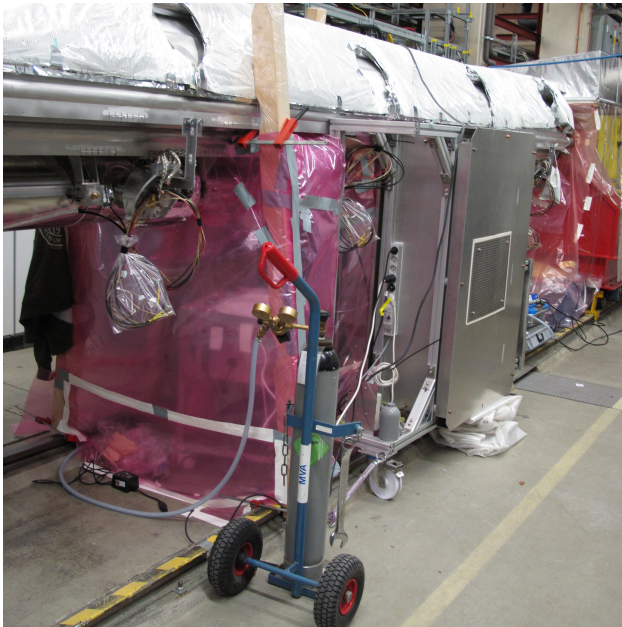
In January 2015 testing of module XM22 started. A leak found at the A-flange of coupler 2 was repaired in situ by exchanging the O-ring. Due to a leak venting the insulation vacuum caused by a loose fastening nut at a coaxial feed-through the testing had to be interrupted and the module warmed up. The flange with the leaky feed-through was exchanged. After the next cool down a heat load 10 times nominal has been found and the module warmed up for investigation. Finally, a  $10^{-9}$  to  $10^{-7} \frac{\text{mbar l}}{\text{s}}$  leak at the beam line appeared. Due to the time delay between the spraying of Helium and the detection inside the beam vacuum volume the leak was expected somewhere at an inner position. We removed the module from the test stand without being tested and stored it in the XFEL tunnel, which was still quite empty at this time. In January 2016 the module was brought back to the AMTF for warm coupler disassembly and subsequently to "Halle 3" for disassembly of the thermal shields permitting access to the string. In March 2016 the HOM #2 feed through of cavity 7 has been found leaky. We decided to try an exchange in a local clean room with the string of cavities still hanging at the cantilever (Fig. 6). To provide access

Figure 6: Local clean room at XM22 hanging at the cantilever for HOM antenna exchange.

to the feed through the tuner was uninstalled. The local clean room has been qualified with particle counters and the feed through exchanged. After reassembly XM22 has been fully tested for the first time in April 2016: All cavities kept their performance w.r.t. the vertical test providing an average gradient of 15.8 MV/m and the heat load measured was within the specification. The module has been installed.
