# SOLVING THE USB COMMUNICATION PROBLEM OF THE HIGH-VOLTAGE MODULATOR CONTROL SYSTEM IN THE EUROPEAN XFEL

M. Bousonville\*, S. Choroba, S. Göller, T. Grevs mühl, A. Hauberg, T. Weinhausen,  
Deutsches Elektronen-Synchrotron DESY, Germany

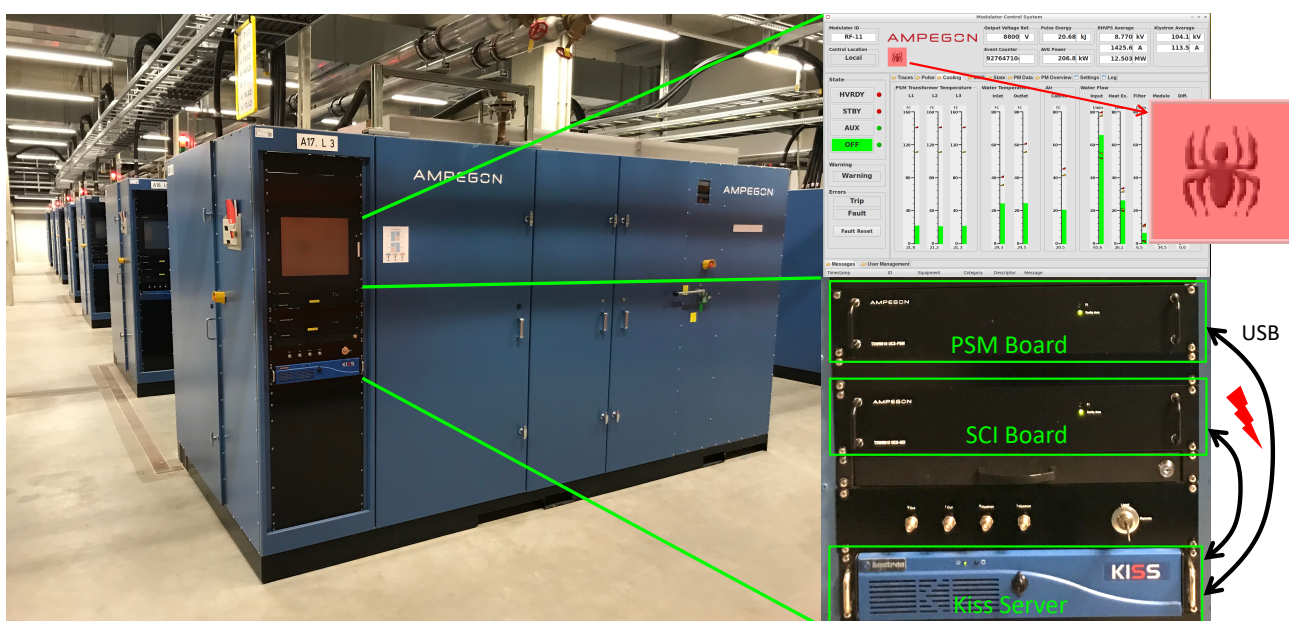
Each RF station consists of a multibeam klystron, high-voltage pulse modulator and pulse transformer, RF waveguide power distribution and several other subsystems. While a number of childhood diseases were eliminated after the commissioning of the European XFEL in 2016 [2], a fault that occurred from time to time in the high-voltage modulators played only a minor role. The modulators generate the high-voltage pulses for the klystrons with an amplitude of 6.3 to 9.2 kV, which are transformed upwards by a factor of 12 by a pulse transformer. So, 75 to 110 kV are available for the klystron operation. The initially unknown error led to the failure of a modulator, which could be fixed by a manual power cycle of the control system. When the error occurred, the GUI of the control system displayed a red spider, which is why this error was internally called the red spider. This error message is always displayed when the communication between the two electronic boards (PSM and SCI) and the server controlling the modulator is disturbed (Fig. 1).

Figure 1: High voltage modulator, GUI and control system.

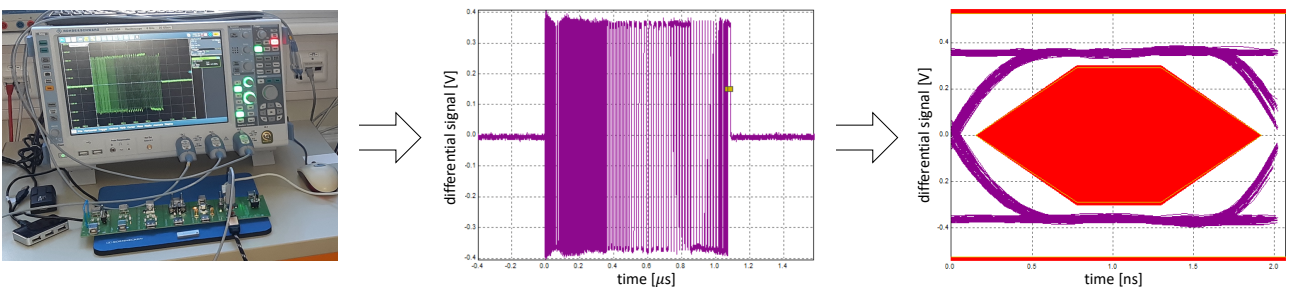
Such an eye diagram consists of the superposition of several hundred to several thousand bits recorded by an oscilloscope. Basically, one can say that the wider the eye is open, the better the signal quality. Theoretically, the eye opening of a USB 2.0 signal should be 800 mV. But due to amplitude noise, the eye opening is reduced in practice. If you also consider the attenuation of a connected USB cable, the vertical eye opening is further reduced. We compared different USB devices and noticed two things. First, the eye diagram of the modulator server and the boards is 5 to 9 % less wide open vertically than other typical USB devices. Secondly, the cable used at the time reduced the eye opening, by a further 8 to 11 %. As a general rule, reducing the eye-opening leads to an increased bit error rate. For a typical USB application, the resulting bit error rate would probably not be a problem, as it does not have to run error-free for a long time.

Figure 2: USB signal measurement setup, recorded bit test sequence and the corresponding eye diagram.

In our case, however, it led to a communication error every one or two months, which caused the failure of a modulator and thus the entire RF station. This results to a MTBF of 2 days for 26 RF stations. The USB analyser opened the eye so much that no more bit errors occurred. The same effect can also be achieved by reducing the cable attenuation.

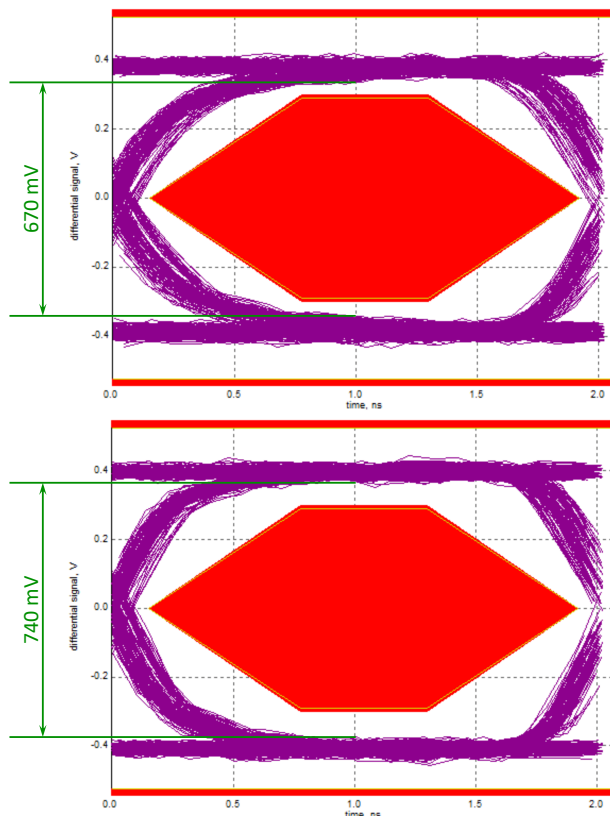
However, the repeaters are active components with unknown lifetime and which therefore carry a potential risk of failure. Therefore, we looked for a USB cable with lower attenuation to achieve a large eye opening without repeaters that could fail. This was not easy, as most manufacturers do not specify the attenuation, but we finally found a cable that has a barely measurable insertion loss. Fig. 3 shows an eye diagram of a USB signal at the end of the transmission with the original cable at the top and with the new cable at the bottom. The eye is about 10 % more open vertically.

Figure 3: Top - Eye diagram with the USB cable previously used in the modulator control system. Below - Eye opened wider due to the much lower attenuation of the new USB cable.

In December 2020, all modulators were then equipped with these cables. In the next 4 months, no more errors occurred and the problem seemed to be finally solved, but the problem showed up again 7 times between May and August.
