# SOLVING THE USB COMMUNICATION PROBLEM OF THE HIGH-VOLTAGE MODULATOR CONTROL SYSTEM IN THE EUROPEAN XFEL

M. Bousonville\*, S. Choroba, S. Göller, T. Grevs mühl, A. Hauberg, T. Weinhausen,  
Deutsches Elektronen-Synchrotron DESY, Germany

## Abstract

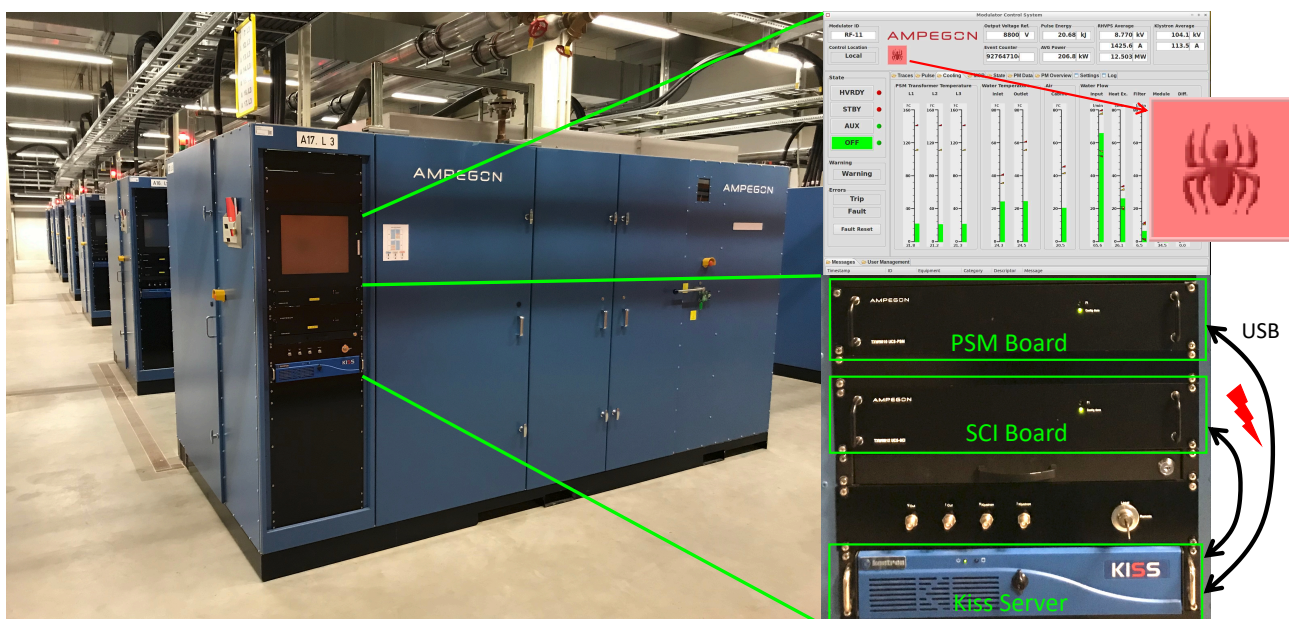
Each RF station consists of a multibeam klystron, high-voltage pulse modulator and pulse transformer, RF waveguide power distribution and several other subsystems. While a number of childhood diseases were eliminated after the commissioning of the European XFEL in 2016 [2], a fault that occurred from time to time in the high-voltage modulators played only a minor role. The modulators generate the high-voltage pulses for the klystrons with an amplitude of 6.3 to 9.2 kV, which are transformed upwards by a factor of 12 by a pulse transformer. So, 75 to 110 kV are available for the klystron operation. The initially unknown error led to the failure of a modulator, which could be fixed by a manual power cycle of the control system. When the error occurred, the GUI of the control system displayed a red spider, which is why this error was internally called the red spider. This error message is always displayed when the communication between the two electronic boards (PSM and SCI) and the server controlling the modulator is disturbed (Fig. 1).

Figure 1: High voltage modulator, GUI and control system.

However, it was completely unclear what had disturbed the communication. In the first two years of operation, the failure occurred 3 to 4 times per year (MTBF = 104 days). The failures were documented but not followed up. This then changed in the two subsequent years of 2018 and 2019. The fault now occurred 20 times per year (MTBF = 18 days) and the investigation began. It was very difficult as the fault occurred completely unpredictably on more than half of the 26 modulators. From January 2020, the probability of the fault occurring increased tenfold and it occurred on average every second day.

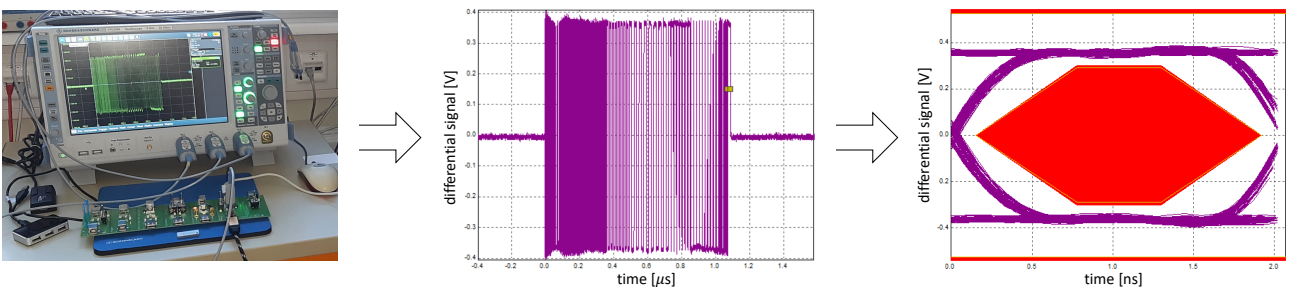
This working hypothesis had to be tested. This requires a complex measurement setup consisting of an oscilloscope with a bandwidth of 2.5 GHz, a special board for the signal taps and appropriate software, which is offered by some manufacturers. With the help of this measurement setup, eye diagrams of the signals can be recorded, which can be used to assess the signal quality (Fig. 2).

Such an eye diagram consists of the superposition of several hundred to several thousand bits recorded by an oscilloscope. Basically, one can say that the wider the eye is open, the better the signal quality. Theoretically, the eye opening of a USB 2.0 signal should be 800 mV. But due to amplitude noise, the eye opening is reduced in practice. If you also consider the attenuation of a connected USB cable, the vertical eye opening is further reduced. We compared different USB devices and noticed two things. First, the eye diagram of the modulator server and the boards is 5 to 9 % less wide open vertically than other typical USB devices. Secondly, the cable used at the time reduced the eye opening, by a further 8 to 11 %. As a general rule, reducing the eye-opening leads to an increased bit error rate. For a typical USB application, the resulting bit error rate would probably not be a problem, as it does not have to run error-free for a long time.

Figure 2: USB signal measurement setup, recorded bit test sequence and the corresponding eye diagram.

In our case, however, it led to a communication error every one or two months, which caused the failure of a modulator and thus the entire RF station. This results to a MTBF of 2 days for 26 RF stations. The USB analyser opened the eye so much that no more bit errors occurred. The same effect can also be achieved by reducing the cable attenuation.

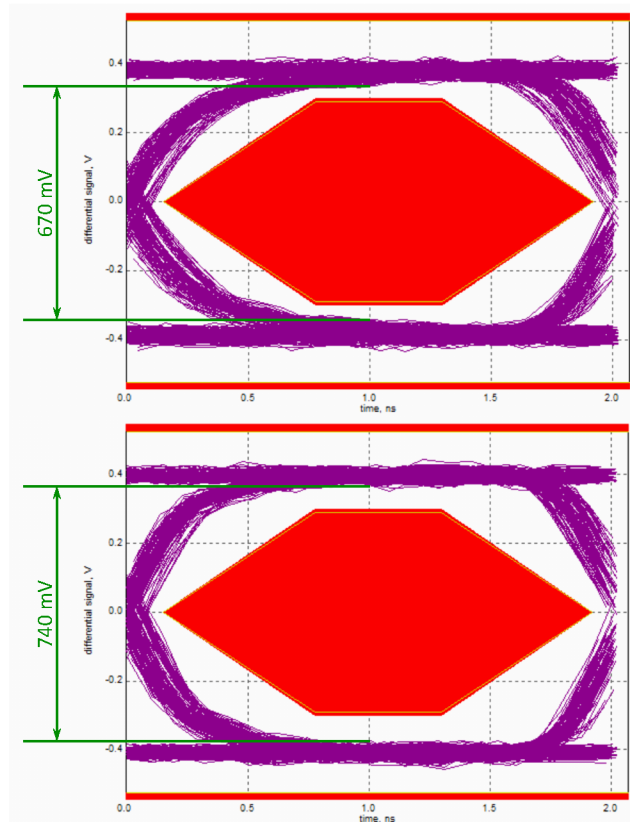
However, the repeaters are active components with unknown lifetime and which therefore carry a potential risk of failure. Therefore, we looked for a USB cable with lower attenuation to achieve a large eye opening without repeaters that could fail. This was not easy, as most manufacturers do not specify the attenuation, but we finally found a cable that has a barely measurable insertion loss. Fig. 3 shows an eye diagram of a USB signal at the end of the transmission with the original cable at the top and with the new cable at the bottom. The eye is about 10 % more open vertically.

Figure 3: Top - Eye diagram with the USB cable previously used in the modulator control system. Below - Eye opened wider due to the much lower attenuation of the new USB cable.

In December 2020, all modulators were then equipped with these cables. In the next 4 months, no more errors occurred and the problem seemed to be finally solved, but the problem showed up again 7 times between May and August.

We then took another measure. We used a USB repeater that can transfer data at a maximum of full speed (Tab. 1). This forces the USB 2.0 interfaces in the electronic boards and the server to reduce the data rate and increase the level. Each bit thus becomes longer by a factor of 40 and the voltage level is increased by a factor of 4.125. This makes the eye correspondingly larger and thus the signal-to-noise ratio is significantly improved, which makes a bit error much less likely. The data rate of 12 Mbit/s is sufficient for the communication within the control system. In August 2021, the USB 1.1 repeater was installed in all modulators and no red spider has been seen since in operation.
