# SOLVING THE USB COMMUNICATION PROBLEM OF THE HIGH-VOLTAGE MODULATOR CONTROL SYSTEM IN THE EUROPEAN XFEL

M. Bousonville\*, S. Choroba, S. Göller, T. Grevsmühl, A. Hauberg, T. Weinhausen  
Deutsches Elektronen-Synchrotron, Hamburg, Germany

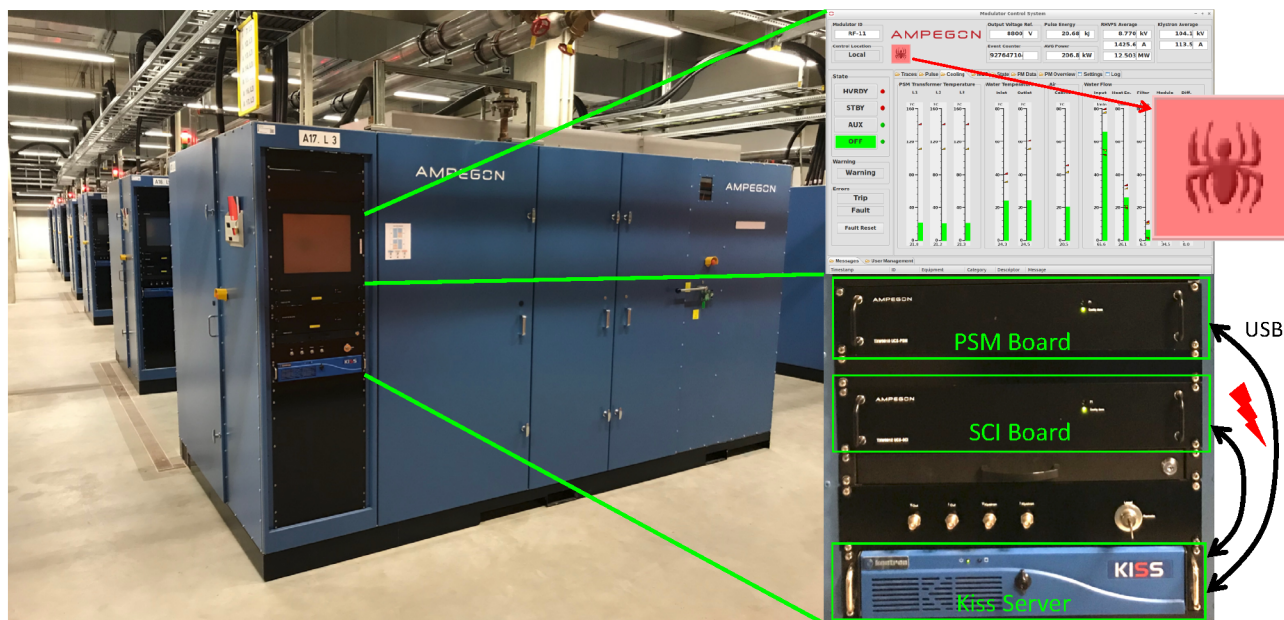
Each RF station consists of a multibeam klystron, high-voltage pulse modulator and pulse transformer, RF waveguide power distribution and several other subsystems. While a number of childhood diseases were eliminated after the commissioning of the European XFEL in 2016 [2], a fault that occurred from time to time in the high-voltage modulators played only a minor role. The modulators generate the high-voltage pulses for the klystrons with an amplitude of 6.3 to 9.2 kV, which are transformed upwards by a factor of 12 by a pulse transformer. So, 75 to 110 kV are available for the klystron operation. The initially unknown error led to the failure of a modulator, which could be fixed by a manual power cycle of the control system. When the error occurred, the GUI of the control system displayed a red spider, which is why this error was internally called the red spider. This error message is always displayed when the communication between the two electronic boards and the server controlling the modulator is disturbed (Fig. 1).

Figure 1: High voltage modulator, GUI and control system.

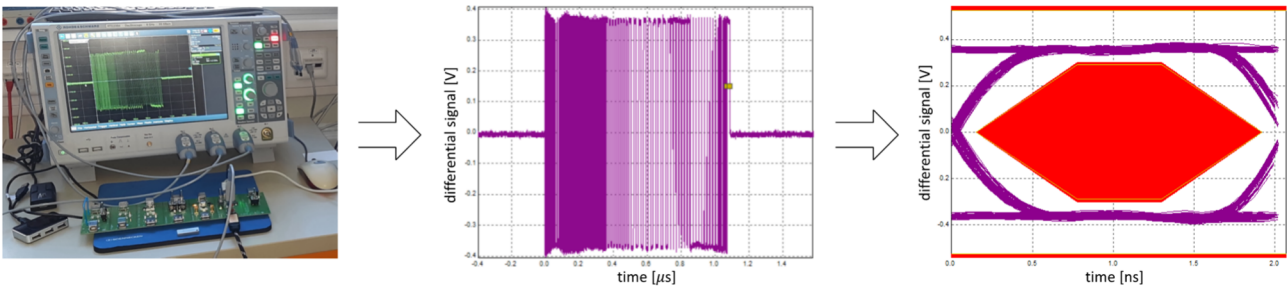
Such an eye diagram consists of the superposition of several hundred to several thousand bits recorded by an oscilloscope. Basically, one can say that the wider the eye is open, the better the signal quality. Theoretically, the eye opening of a USB 2.0 signal should be 800 mV. But due to amplitude noise, the eye opening is reduced in practice. If you also consider the attenuation of a connected USB cable, the vertical eye opening is further reduced. We compared different USB devices and noticed two things. First, the eye diagram of the modulator server and the boards is 5 to 9 % less wide open vertically than other typical USB devices. Secondly, the cable used at the time reduced the eye opening, by a further 8 to 11 %. As a general rule, reducing the eye-opening leads to an increased bit error rate. For a typical USB application, the resulting bit error rate would probably not be a problem, as it does not have to run error-free for a long time.

Figure 2: USB signal measurement setup, recorded bit test sequence and the corresponding eye diagram.

In our case, however, it led to a communication error every one or two months, which caused the failure of a modulator and thus the entire RF station. This results to a MTBF of 2 days for 26 RF stations. The USB analyser opened the eye so much that no more bit errors occurred. The same effect can also be achieved by reducing the cable attenuation.

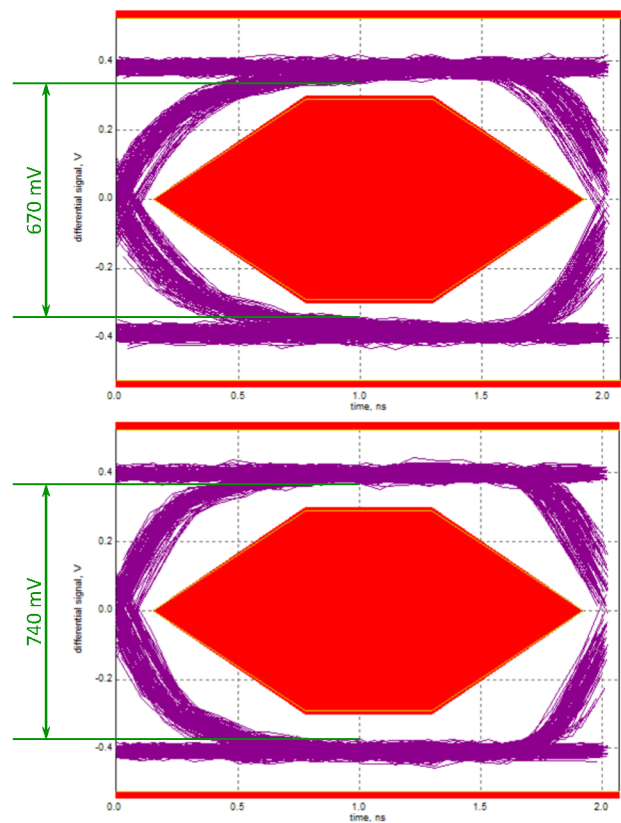
However, the repeaters are active components with unknown lifetime and which therefore carry a potential risk of failure. Therefore, we looked for a USB cable with lower attenuation to achieve a large eye opening without repeaters that could fail. This was not easy, as most manufacturers do not specify the attenuation, but we finally found a cable that has a barely measurable insertion loss. Figure 3 shows an eye diagram of a USB signal at the end of the transmission with the original cable at the top and with the new cable at the bottom. The eye is about 10 % more open vertically.

Figure 3: Top - Eye diagram with the USB cable previously used in the modulator control system. Below - Eye opened wider due to the much lower attenuation of the new USB cable.

In December 2020, all modulators were then equipped with these cables. In the next 4 months, no more errors occurred and the problem seemed to be finally solved, but the problem showed up again 7 times between May and August.
