INVESTIGATION OF SAMPLES SEPARATED FROM PROTOTYPE CAVITIES OF THE EUROPEAN XFEL

X. Singer, S. Aderhold, A. Ermakov, D. Reschke, W. Singer, K. Twarowski, (DESY, Germany)
M. Hoss, D. Watzal (Heraeus, Germany)

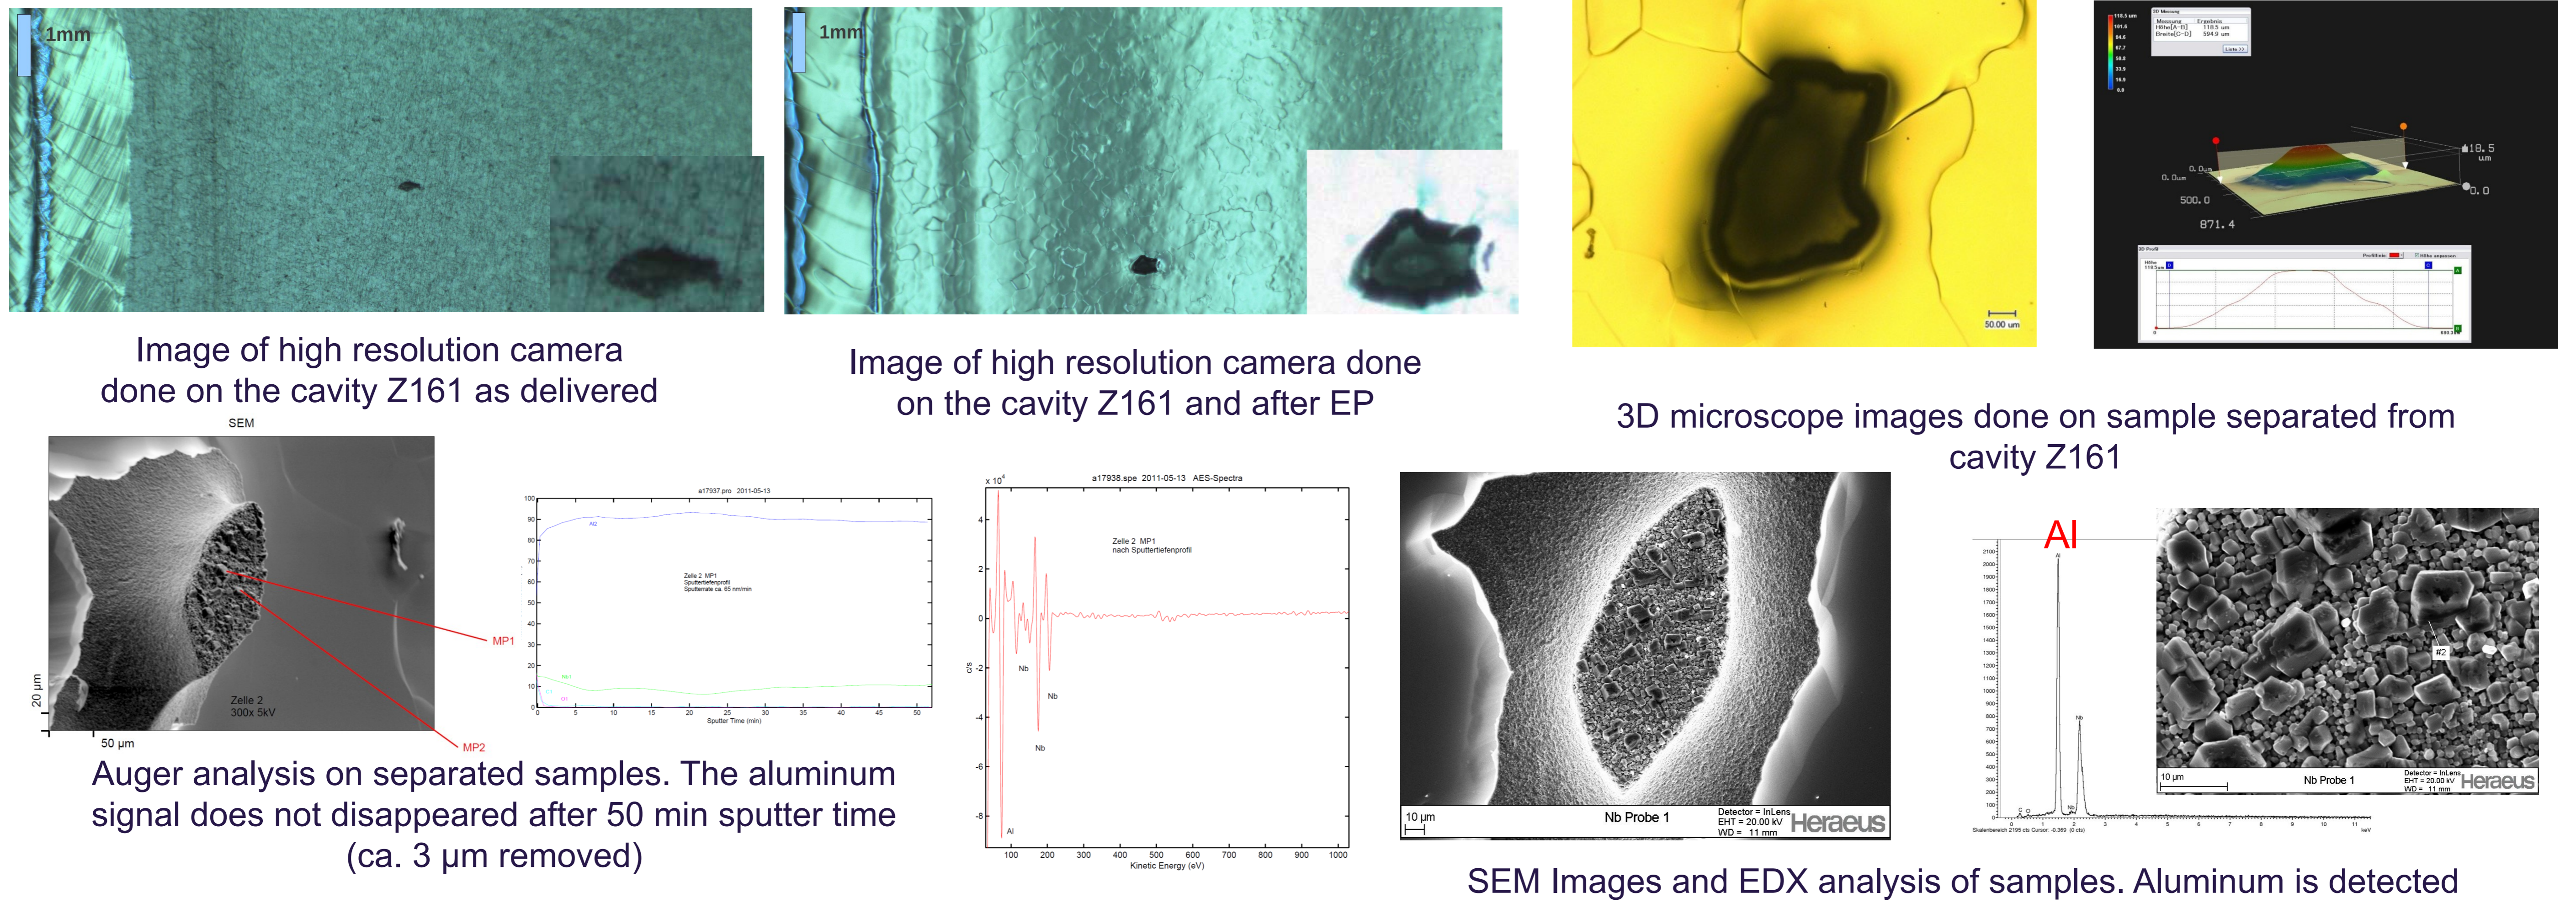
Detected foreign elements (Aluminium): Cavity Z161, Cell2, 128°. Quench in π -mode at 13,7 MV/m

- Aluminium detected in the black spot of cavity Z161, cell 2 caused quench according T-map. Another spots with Al also detected. Defects with Al are protruded.

- Defects with Al of cavity Z161, cell 2 investigated by Auger has a thickness at least more than 3 μm (not a thin layer)
- It was found out (P. Michelato) that tools used for cavity EB welding can produce Al particles during cavity assembly. Probably some Al particles are adhered on the surface and partially melted during EB welding

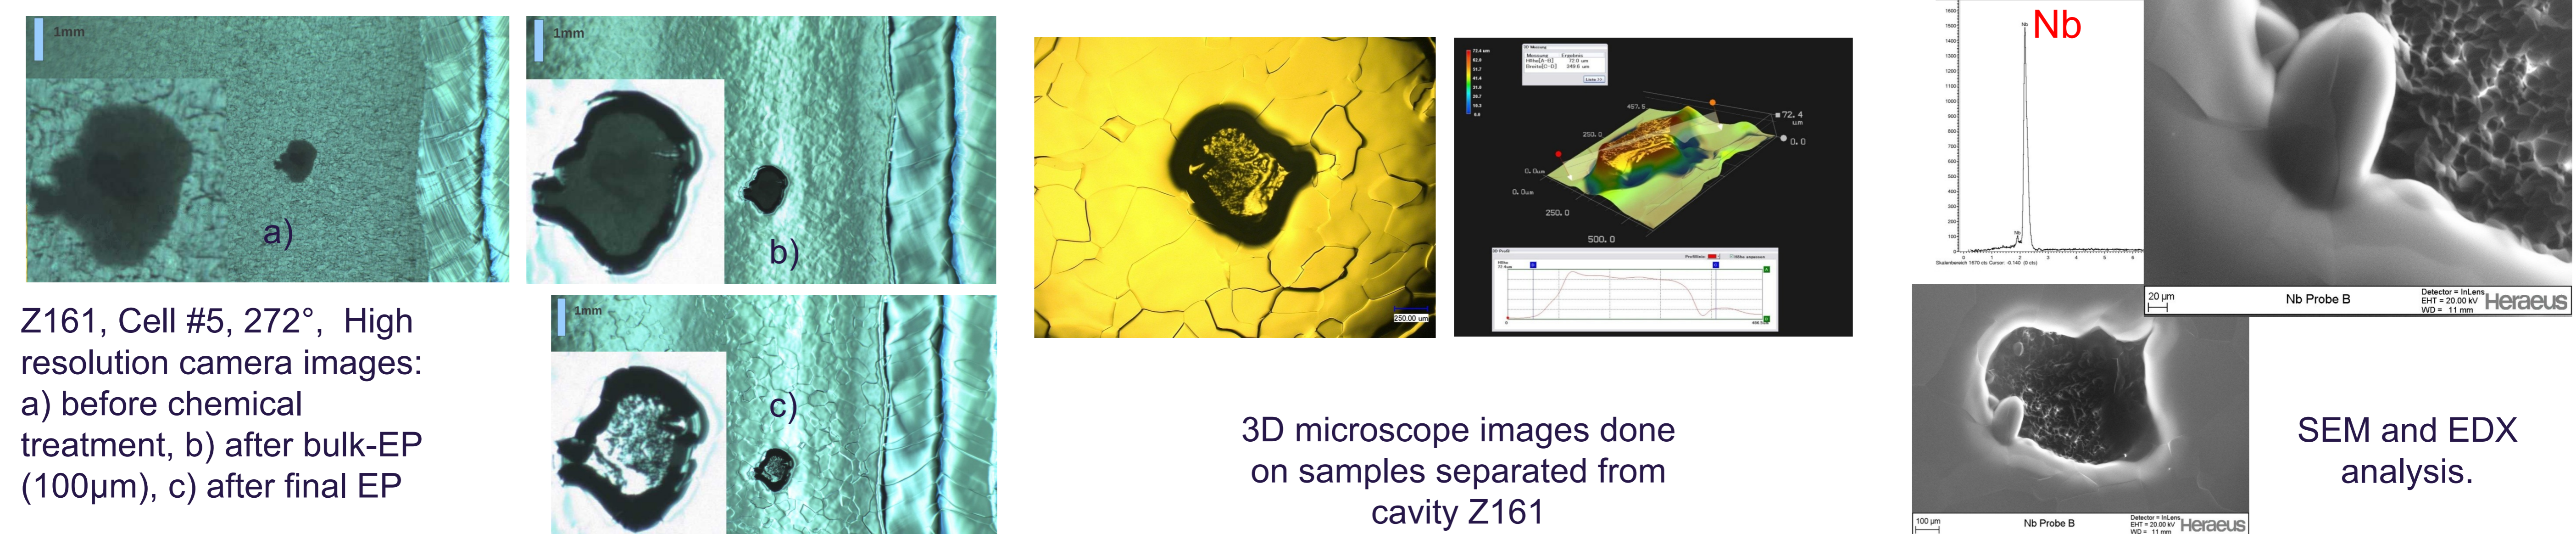
Cavity Z161, Sample B: Quench in 7/9-, 5/9- and 1/9-pi-mode, 21 MV/m, cell 5, Tmap: 280°. Topographical defect (no foreign inclusions)

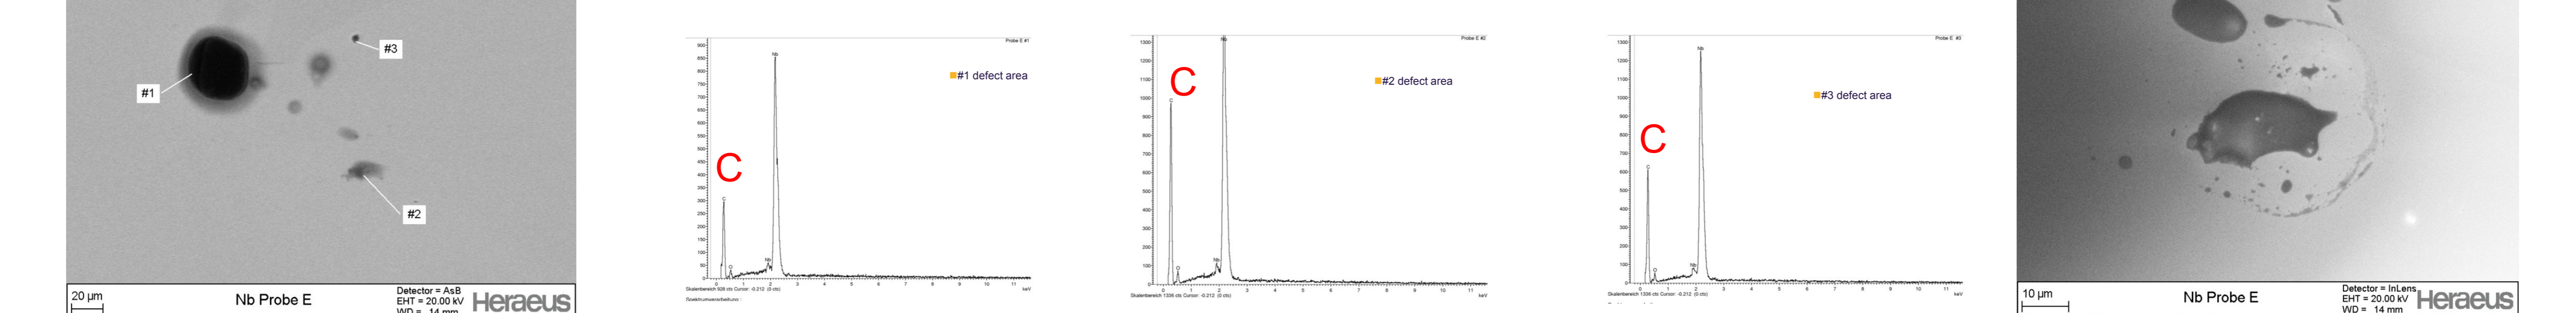
Cavity Z161, sample E (Cell3, 254°). Increased content of carbon

- Spots with increased content of carbon have been detected by EDX in cavity Z161. Similar spots have been observed earlier in samples separated from cavities Z111 and Z130

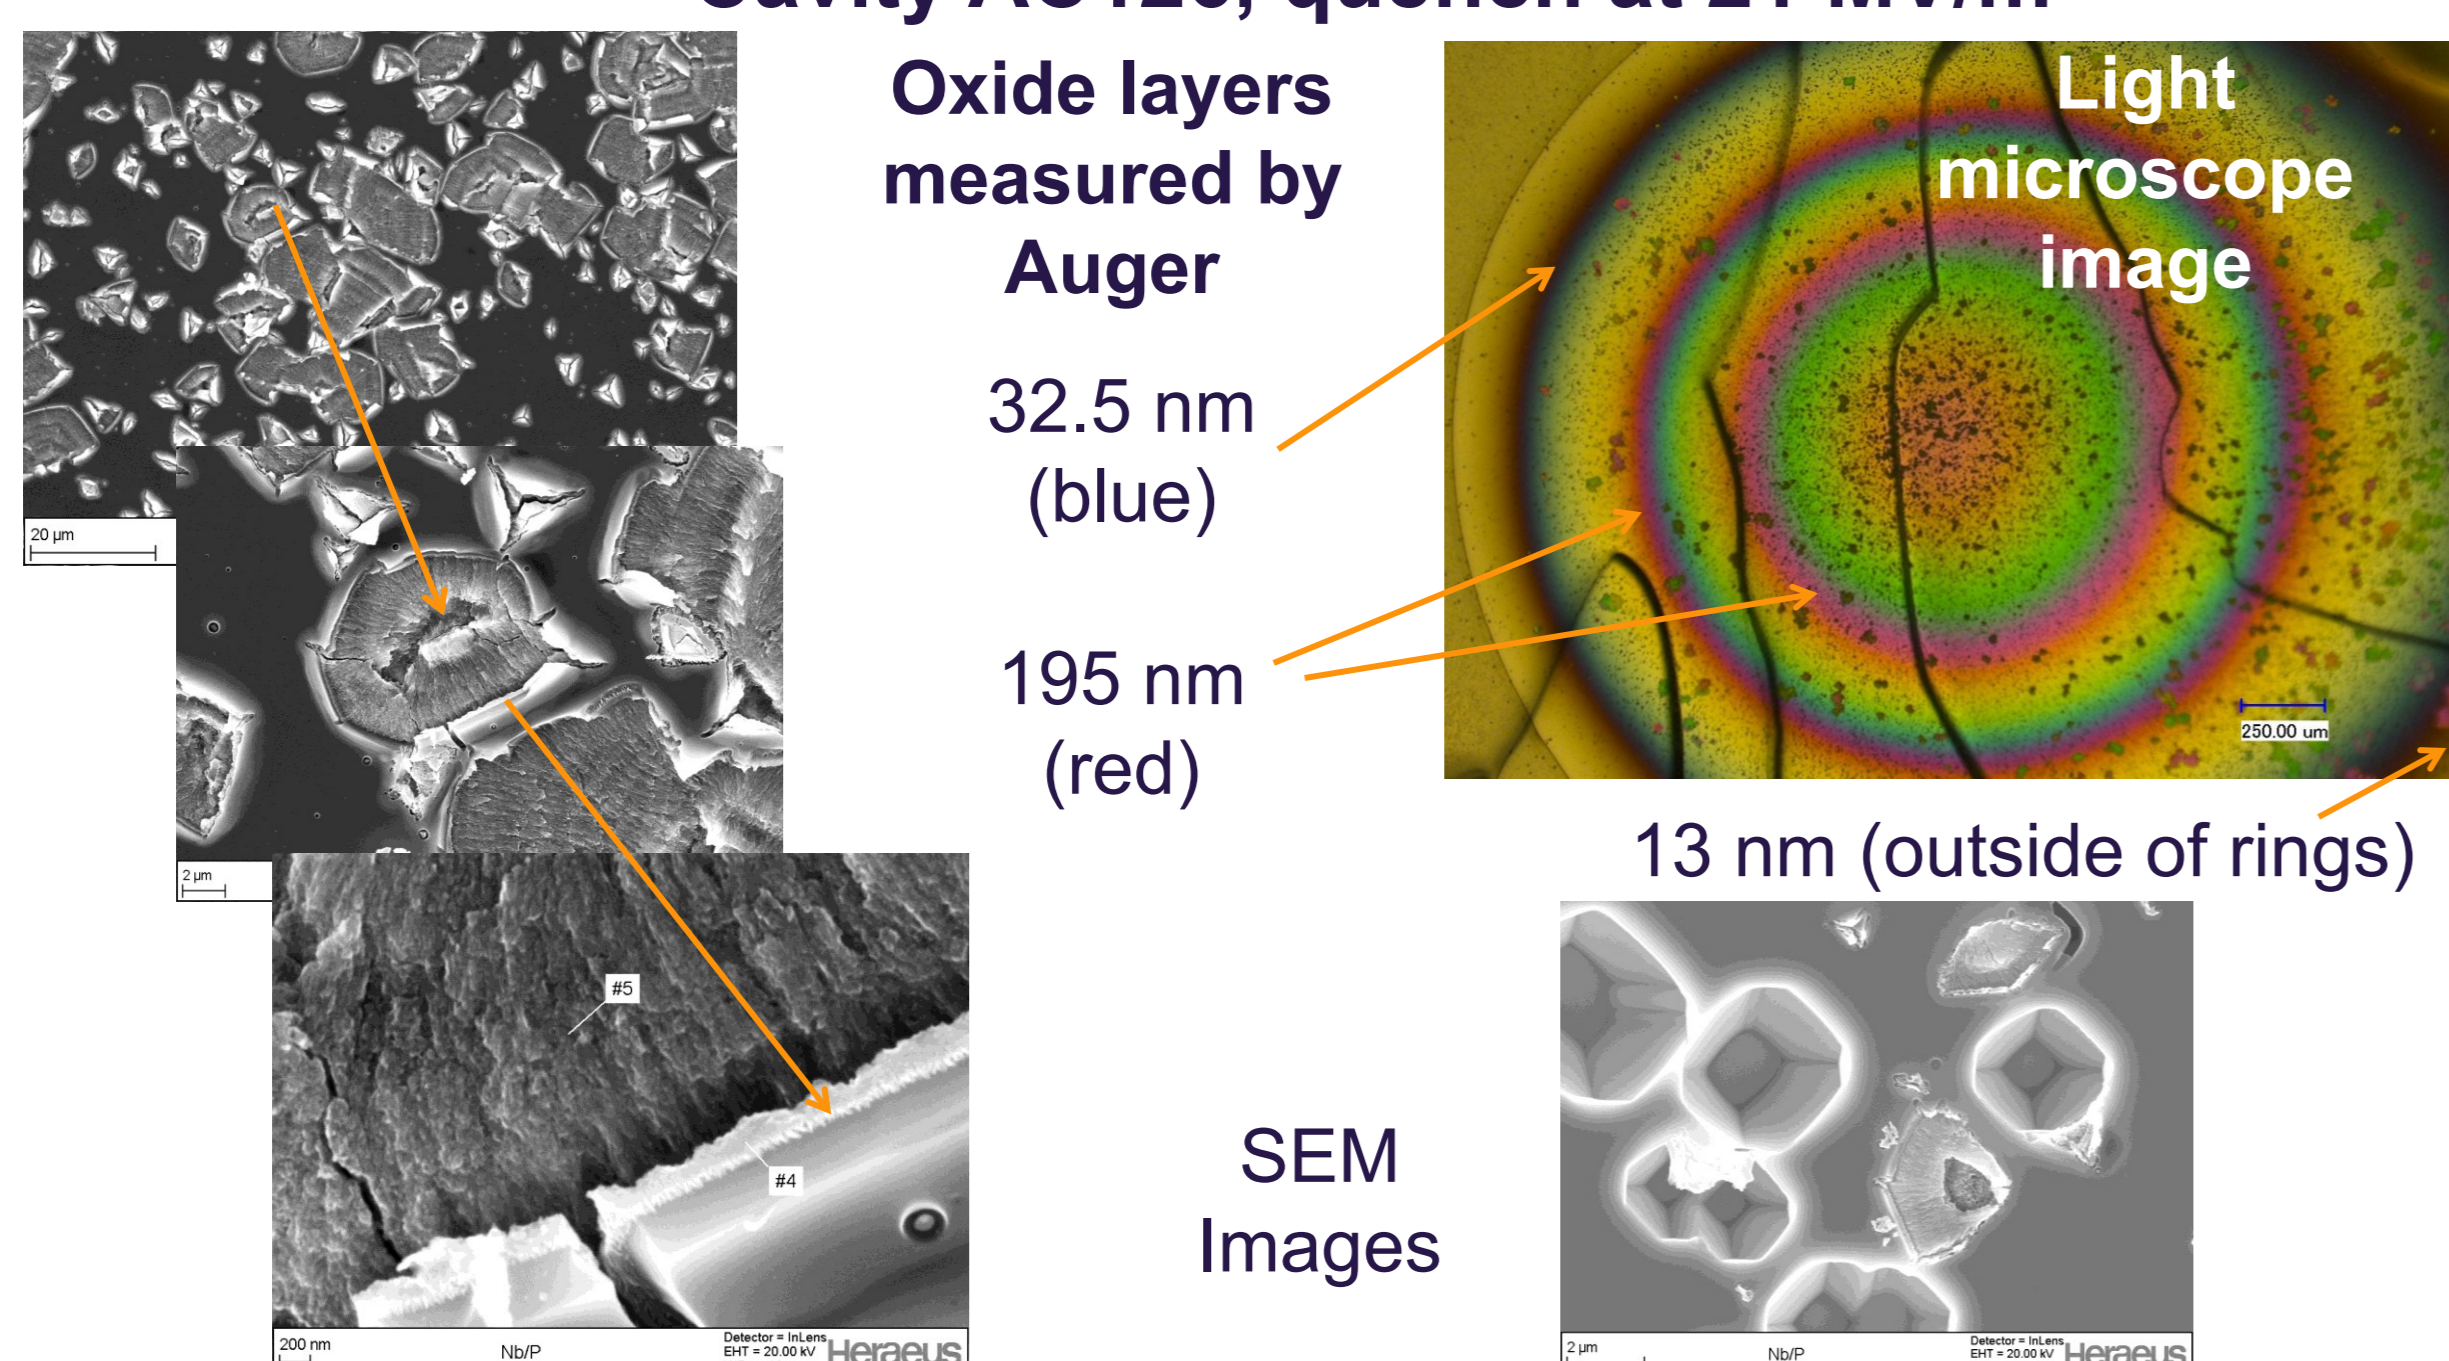
Damaged surface (high pressure water rinsing mark). Cavity AC126, quench at 21 MV/m

Similar marks are observed on another 6 samples from AC126

- A high pressure water rinsing mark was detected in the cavity AC126. This defect caused quench at Eacc of 21 MV/m.
