# The Quest of Building a Precision TPC Field Cage

**Abstract.** For ILD, one of the detector concepts for the proposed International Linear Collider, a time projection chamber (TPC) is foreseen as the central tracking detector. The R&D effort within the LCTPC collaboration has been centred around a common infrastructure setup operated at the DESY II Test Beam Facility. This setup includes a large field cage as test bed for the different readout technologies to be studied under comparable conditions. A second iteration of this field cage has recently been constructed to improve on the shortcomings noticed with its predecessor. The construction was repeatedly delayed and interrupted due to the COVID-19 pandemic but these delays yielded insights that may not otherwise have been observed during an ordinary course of operations. Methods and findings from the build process are reported.

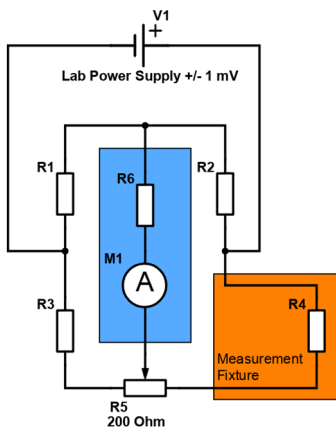
**Fig. 4.** Wheatstone Bridge.

The bridge (Fig. 4) was composed from three resistors R1 to R3 of the batch of resistors with 500 ppm tolerance to be sorted, and a low resistance potentiometer R5 to equalize the bridge with a fourth, arbitrarily picked reference resistor from the batch. A Keithley Source-Meter 2410 was used as power supply V1 and a freshly calibrated Keithley Electrometer 6514 to measure the bridge current M1. This proved to be a very stable setup, capable of measuring deviations of 7 ppm. For an efficient sorting process, the bridge current was measured and the difference of resistance compared to the reference resistor from the batch was calculated from it.

The method is very precise, because the resistor batch is already pre-sorted and thus there are only small deviations that will cause small bridge currents. These can be measured with sufficiently sensitive devices (order of nanoampere, in this case) without the need for a big measurement range or multimeters of utmost precision. In addition, the supply voltage and ambient temperature were logged, and the bridge re-zeroed with the reference resistor to recognize and avoid long-term systematic shifts.

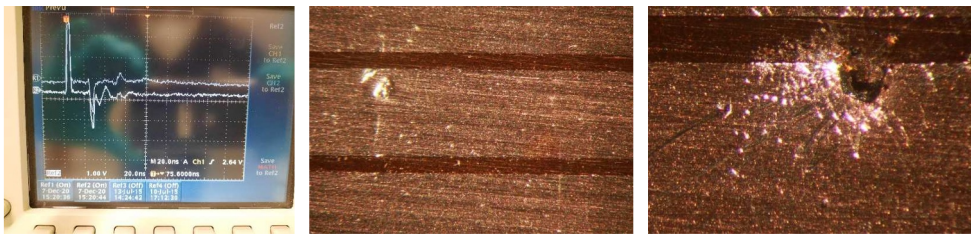
In November 2020 the one good foil was equipped with the sorted batch of precision resistors and tested again. At that point one place in the resistor chain showed a significant deviation of 100 k $\Omega$ . The expected resistance between strips is 750 k $\Omega$ , due to two resistor chains being connected to the strips in parallel. As replacing the resistors did not yield any improvement, another parasitic high impedance connection was assumed. Impurities on the cut edges could be excluded. likewise, the field strip foil was lying on an insulating plastic foil. A comparison of signal runtime between the faulty strips and two strips without problem (Time Domain Reflectometry) finally allowed a rough localization of the fault (Fig. 6a). Upon closer inspection with a microscope a slight bulge in the copper cladding was found (Fig. 6b), which covered a tiny hole of about 0.5 mm diameter (Fig. 6c).

**Fig. 6.** a) TDR signals of a good and the faulty strip. b) Fault location. c) Opened hole (gap: 0.5 mm).

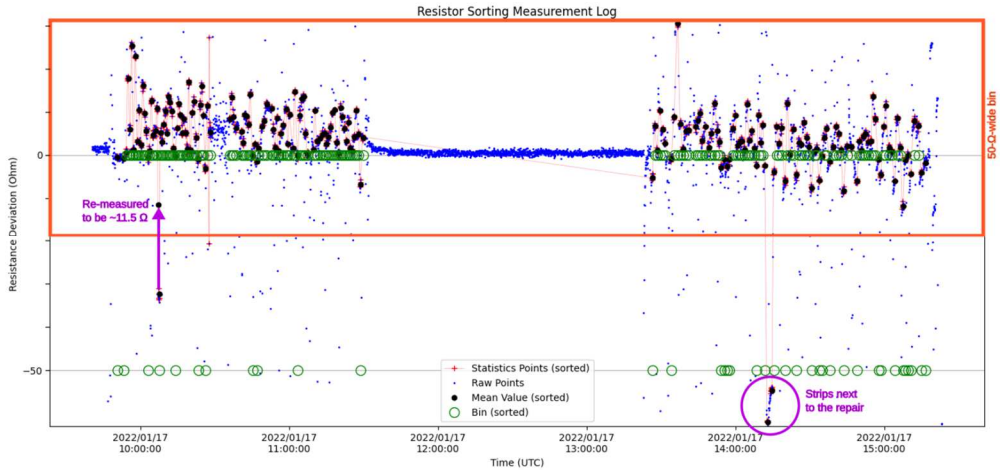
Fig. 9. Example of a log of field strip resistance measurements with one last outlier.

The entire foil was measured again with the specially constructed measurement head. Proceeding strip-wise across the foil, the measurements showed a systematic shift of a few  $100 \Omega$  and still a deviation of  $2 \text{ k}\Omega$  for the repaired strips. Besides, a notable charge-up behaviour was present in most measurements. To mitigate this, it was tried to perform the measurements on an ESD protection mat, however, its resistance was too low and biased the measurements. Measuring directly on the wooden surface of the table removed the charge-up behaviour and the majority of the resistors were within a  $50 \Omega$  band, similar to the bins of the sorted resistors. Also, the deviation of the repaired strip had shrunk to  $1 \text{ k}\Omega$ .

This trend continued until subsequent measurements in January 2022, performed on a different spot on the table surface and with possible noise sources, like metallic sources and the temperature sensor removed from the immediate measurement location. Only the repaired strip was then still outside the  $50 \Omega$  band by merely  $40 \Omega$  (Fig. 9). When the measurement was repeated a week later, to check for a possible exchange, even this difference had vanished and all resistors were now within the targeted  $50 \text{ ppm}$  tolerance band of  $75 \Omega$ .

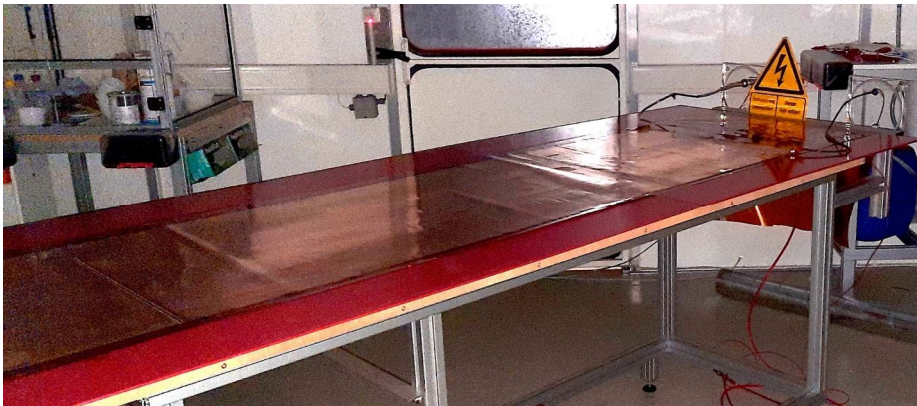
After considerable safety precautions an open high voltage test of the field strip foil were performed end of April 2022. This consisted of a quick test with 30 kV over a few minutes and a test with 25 kV over 24 hours. Both tests were passed without any problems.

Fig. 10. Open high voltage test setup of field strip foil.
