# The Quest of Building a Precision TPC Field Cage

**Abstract.** For ILD, one of the detector concepts for the proposed International Linear Collider, a time projection chamber (TPC) is foreseen as the central tracking detector. The R&D effort within the LCTPC collaboration has been centred around a common infrastructure setup operated at the DESY II Test Beam Facility. This setup includes a large field cage as test bed for the different readout technologies to be studied under comparable conditions. A second iteration of this field cage has recently been constructed to improve on the shortcomings noticed with its predecessor. The construction was repeatedly delayed and interrupted due to the COVID-19 pandemic but these delays yielded insights that may not otherwise have been observed during an ordinary course of operations. Methods and findings from the build process are reported.

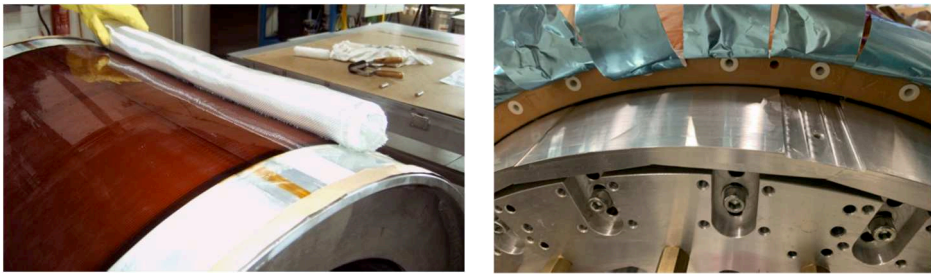
**Fig. 2.** a) Old mandrel during lamination. b) New mandrel in collapsed state.

For improvement on these issues, it was decided to build the second field cage in-house. This would allow to control the material budget in detail and carefully address the challenging geometrical requirements for the composite material design. Compared to the formerly used simple, shrinkable tube mandrel (Fig. 2a), now a reproducibly precise, collapsible, segmented mandrel with alignment stops was used (Fig. 2b). Assembly strategies, different wall structures, material combinations, and electrical and mechanical properties of these were investigated in numerous pre-tests.

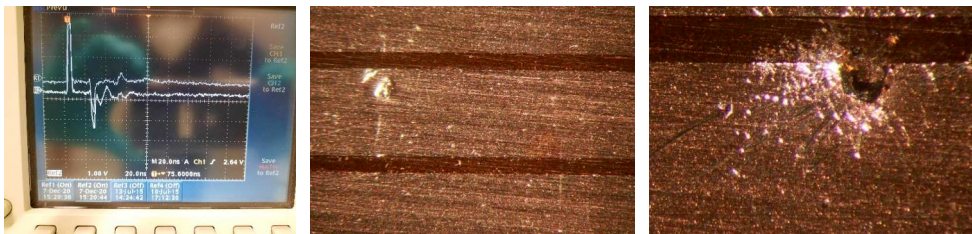
**Fig. 6.** a) TDR signals of a good and the faulty strip. b) Fault location. c) Opened hole (gap: 0.5 mm).

In November 2020 the one good foil was equipped with the sorted batch of precision resistors and tested again. At that point one place in the resistor chain showed a significant deviation of 100 k $\Omega$ . The expected resistance between strips is 750 k $\Omega$ , due to two resistor chains being connected to the strips in parallel. As replacing the resistors did not yield any improvement, another parasitic high impedance connection was assumed. Impurities on the cut edges could be excluded. likewise, the field strip foil was lying on an insulating plastic foil. A comparison of signal runtime between the faulty strips and two strips without problem (Time Domain Reflectometry) finally allowed a rough localization of the fault (Fig. 6a). Upon closer inspection with a microscope a slight bulge in the copper cladding was found (Fig. 6b), which covered a tiny hole of about 0.5 mm diameter (Fig. 6c).

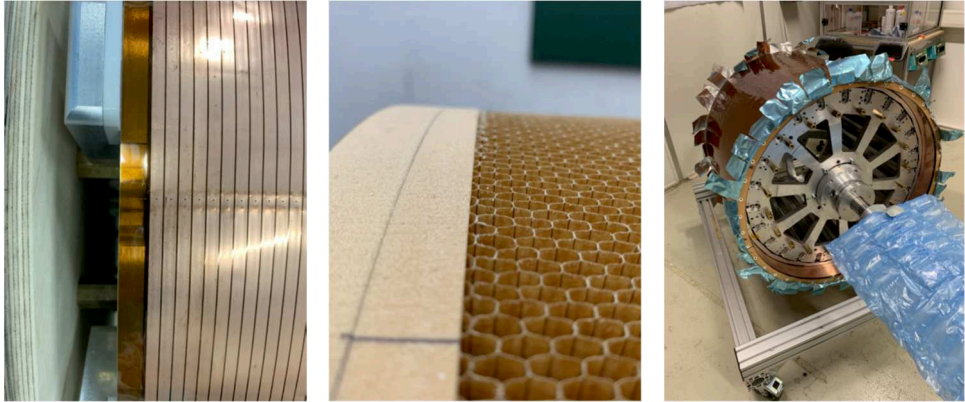
**Fig. 11.** a) Alignment of field strip foil. b) Routed flange honeycomb transition. c) Completed field cage being removed from the mandrel.

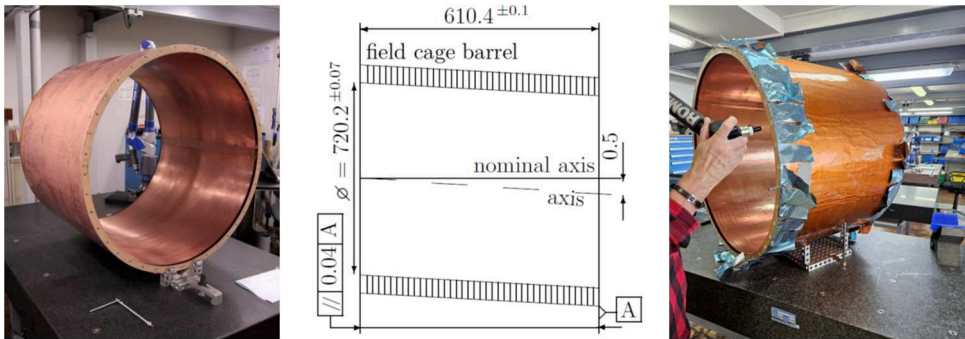
**Fig. 12** a) Survey of first field cage. b) Survey results of first field cage. c) Survey of new field cage.

In June 2024 a geometrical survey of the field cage was undertaken. However, the results are not directly comparable with those of the first field cage, as the measurement equipment had been changed in the 15 years between the two builds. Both field cages were surveyed with a measuring-arm. While the old arm had sufficient reach and precision for the entire field cage, this was not the case for the new equipment. One arm had sufficient reach, but was less precise (order of  $100\ \mu\text{m}$ ) than the one used on the first field cage. Another was more precise, but did not have enough reach to measure both sides. Furthermore, it was difficult to locate features like the field strip edge reliably with the probe.

Nonetheless, the preliminary results with the long-reach arm suggest that the skew of the field cage could be significantly improved with respect to the first field cage (about  $70\ \mu\text{m}$ ). However, other aspects of the build seem to be worse. One flange is tilted and out of parallel to the other by about  $400\ \mu\text{m}$ . The alignment of the field strips with respect to the flanges and at the seam of the foil is off by about  $200\ \mu\text{m}$ . As great care was taken for the initial alignment of the field strip foil on the mandrel, the cause for these deviations are likely shifts induced by the tool movements during the lamination process.
