ILC-HiGrade cavities as a tool of quality control for the EXFEL and further SRF R&D

- Motivation and goal
- European EXFEL/ILC-HiGrade program
- Results of cold RF test of the EXFEL/ILC-HiGrade cavities
- Quality control tools and actual results

Aliaksandr Navitski *aliaksandr.navitski@desy.de

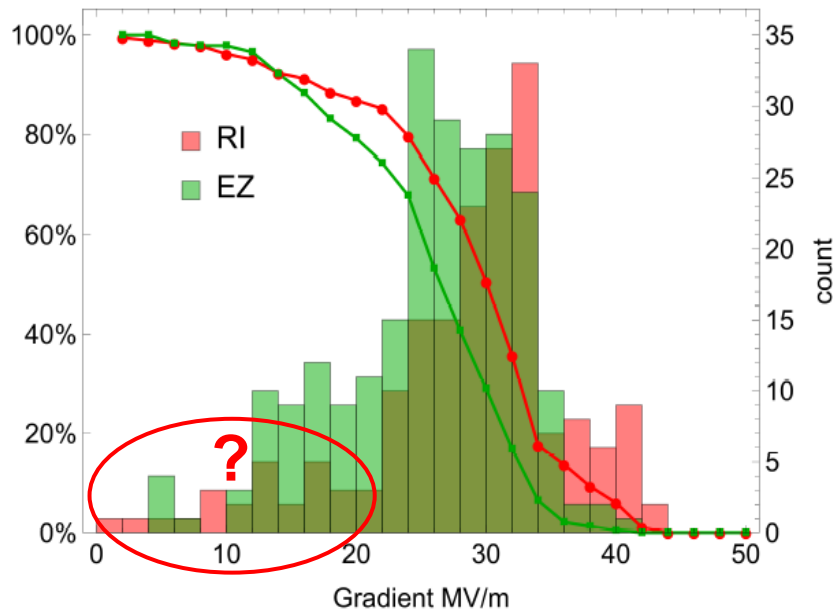
Usable gradient of EXFEL cavities (as received*)

- “ILC recipe” provides cavities with usable gradient of $\sim 31.9 \pm 8.2$ MV/m (34.9 ± 4.7 MV/m after retreatment)
- some achieve >40 MV/m

- Main limitation is FE
