Influence of 3D connectivity of rigid phases on damage evolution during tensile deformation of an AlSi12Cu4Ni2 piston alloy

To appear in: *Materials Science & Engineering A*

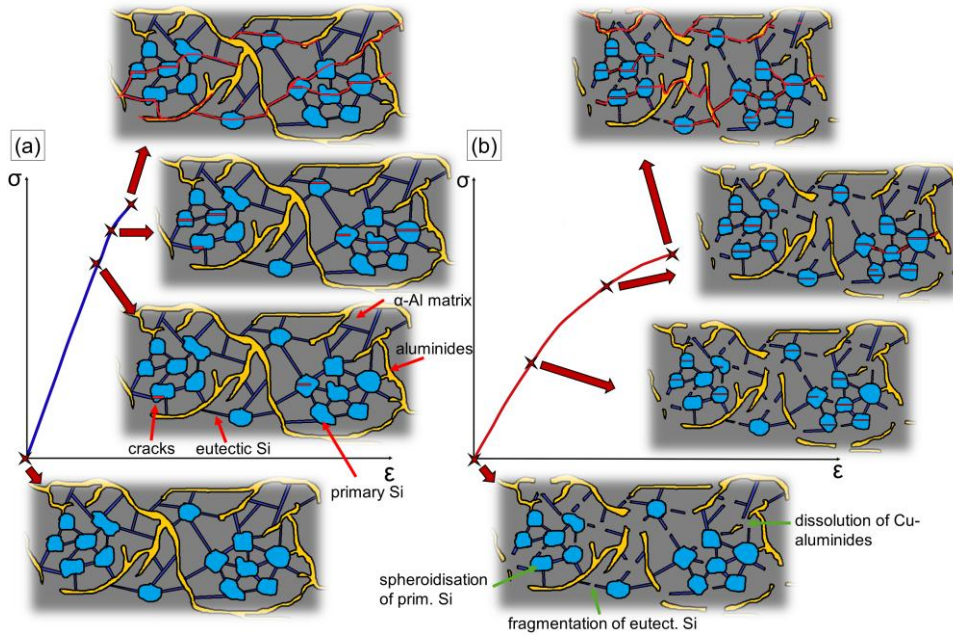
➤ Fig. 14: Schematic illustration of the damage behaviour of the AlSi12Cu4Ni2 alloy (a) 0h ST and (b) 4h ST. The load direction is vertical.

Fig. 14 presents a schematic illustration of the different damage accumulation behaviours between the 0h ST and 4h ST conditions. In the 0h ST condition the material is formed by a highly interconnected network of rigid phases with a high *connectedness* embedded in the α -Al matrix (see Fig. 14 (a); light blue: prim. Si, dark blue: eutectic Si, yellow: aluminides, grey: matrix). In an early stage of deformation only a few cracks are formed through primary Si particles. As deformation proceeds, damage accumulates in the form of further cracks at clusters of primary Si particles. Finally, sudden failure occurs with the main crack propagating through the connected rigid phases (Si and aluminides) and pre-existing micro-cracks. In comparison, the 4h ST condition shows less connecting branches within the highly interconnected network of rigid phases (Fig. 14 (b)), i.e. less *connectedness*. Damage initiation occurs at a later deformation stage since the matrix is able to accommodate part of the plastic strain owing to the lower rigidity of the interconnected network. Therefore, the alloy in this condition is able to sustain more damage, which, similarly to the 0h ST condition, accumulates as cracks in clusters of Si particles. Failure occurs by coalescence of neighbouring micro-cracks, but the lower amount of connecting branches within the rigid networks implies that the main crack has less paths for rapid propagation and, thus, final fracture occurs at higher strain than in the 0h ST condition.
