Quality concerns caused by quality control — deformation of silicon strip detector modules in thermal cycling tests

To cite this article: Richard Salami *et al* 2025 *JINST* **20** P03004

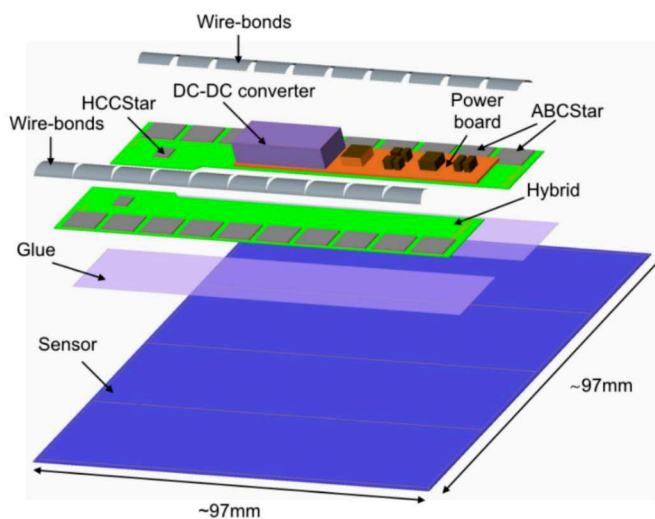
Figure 1. Exploded view of barrel module components. Reproduced from [1]. © 2024 IOP Publishing Ltd and Sissa Medialab. All rights reserved.

Modules are constructed from components in a series of manual precision assembly steps, with module component materials and thicknesses indicated in table 1. Modules in the barrel region, shown in figure 1, are square long-strip (LS) or short-strip (SS). Modules in the endcap are approximately trapezoidal, with curved edges. Hybrids are the flexible circuit boards that hold the readout chips (ASICs) responsible for registering hit signals, as well as housing thermistors for temperature monitoring. The powerboard provides the DC-DC power for the module.

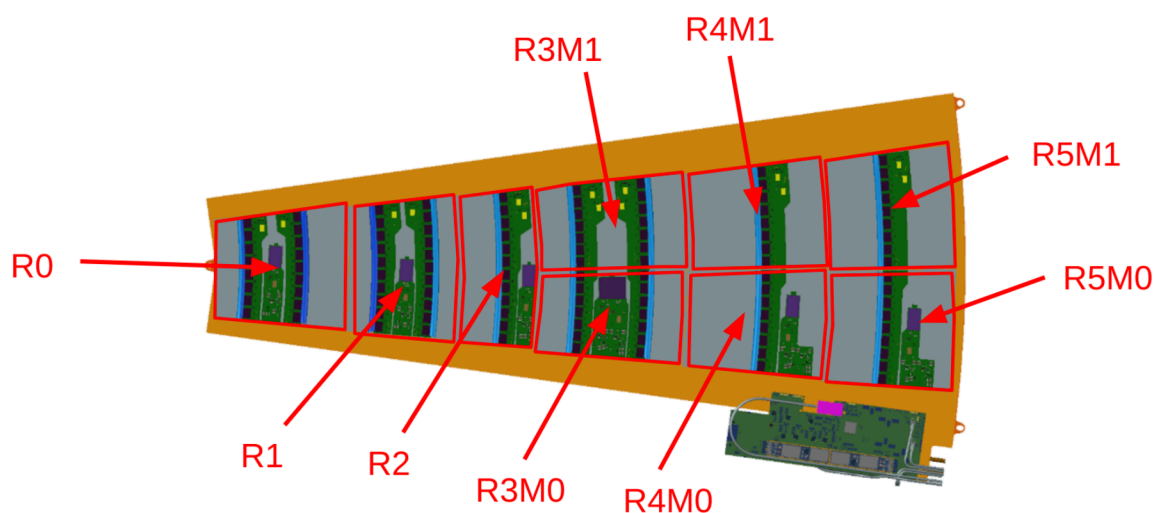
**Figure 2.** Schematic of a petal loaded with completed endcap modules.

Modules that pass all QC requirements are glued and wirebonded to staves or petals, shown in figure 2. The analyses presented in this study rely on measurements of the module shape (see section 2.1) and module leakage current tests (see section 2.2) in QC.

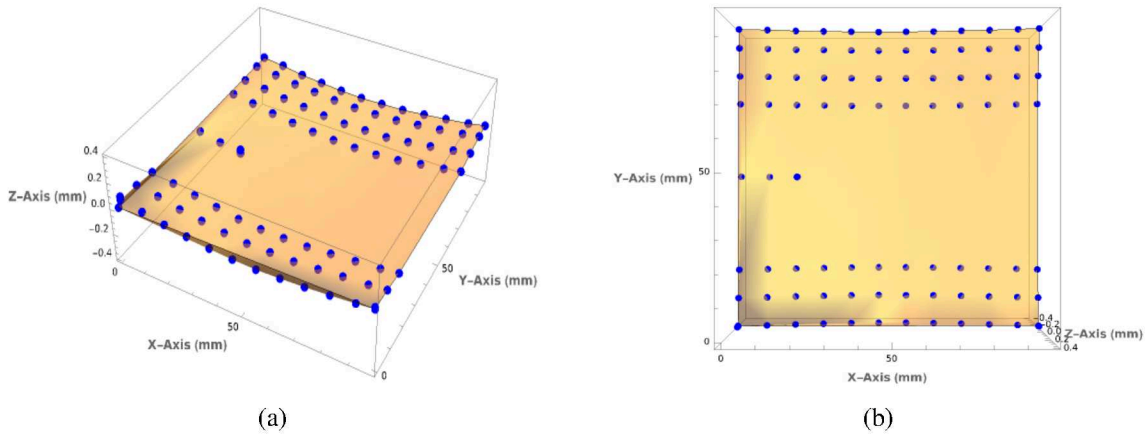
Figure 3. Measurement grid on a barrel module. The blue points represent measurements taken in the module shape test, with the full module shape interpolated in orange. The powerboard and hybrid flexes are not measured, as they are not considered in the module shape.

Module shapes are measured with the module placed on a flat surface to obtain its natural shape. Out-of-plane height measurements are taken on a grid of points across the sensor surface that are at most 1 cm apart, see figure 3. This is the general procedure for the module shape tests.

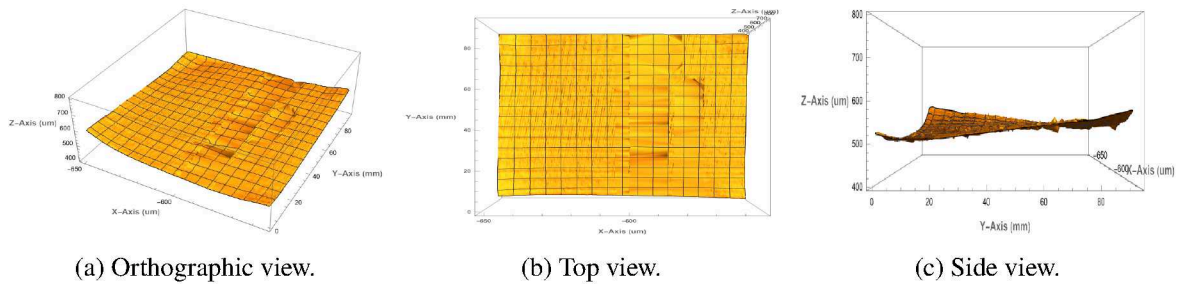
Figure 4. Tilt corrected surface map of a barrel module. The tilt corrected data yields a shape coefficient of $+51 \mu\text{m}$. The tilt correction generally has a negligible effect on the calculated shape coefficient, suggesting that the placement of the modules during measurement does not distort the calculated shape coefficients.

The shape measurements form a surface map of the measured module. To calculate the shape coefficient, only points on the sensor are considered (i.e. points measured on flexes or readout chips are not considered). Using all the sensor surface points, a tilt corrected surface map is obtained by using a plane fit, an example of which is shown in figure 4. The maximum height difference between

points on the sensor is used as the module shape coefficient. The module shown in figure 4 is a typical module that falls within the specifications for module shape coefficient. The shape of the module is consistent with the deformation introduced by the assembly process, which is acceptable for loading a module onto a support structure.

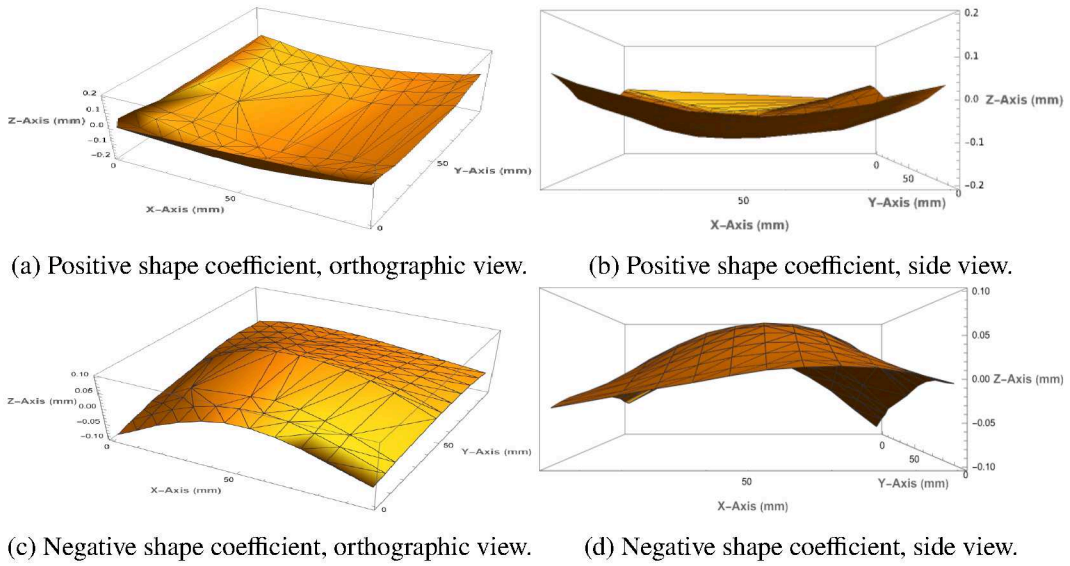
Figure 5. Barrel module exhibiting a positive module shape coefficient in (a) and (b) of $+181 \mu\text{m}$. Barrel module with a negative module shape coefficient in (c) and (d) of $-339 \mu\text{m}$. These two modules show a large bow that is outside specification for completed modules, such that they failed the shape test in QC.

A positive module shape coefficient is defined by a global minimum for a module surface with local maxima, such that the module centre is below the edges forming a bowl shape, as shown in figure 5(a) and figure 5(b). A negative module shape coefficient is defined by a global maximum for a module surface with local minima, such that the module centre is above the edges, forming a hill shape, as shown in figure 5(c) and figure 5(d).

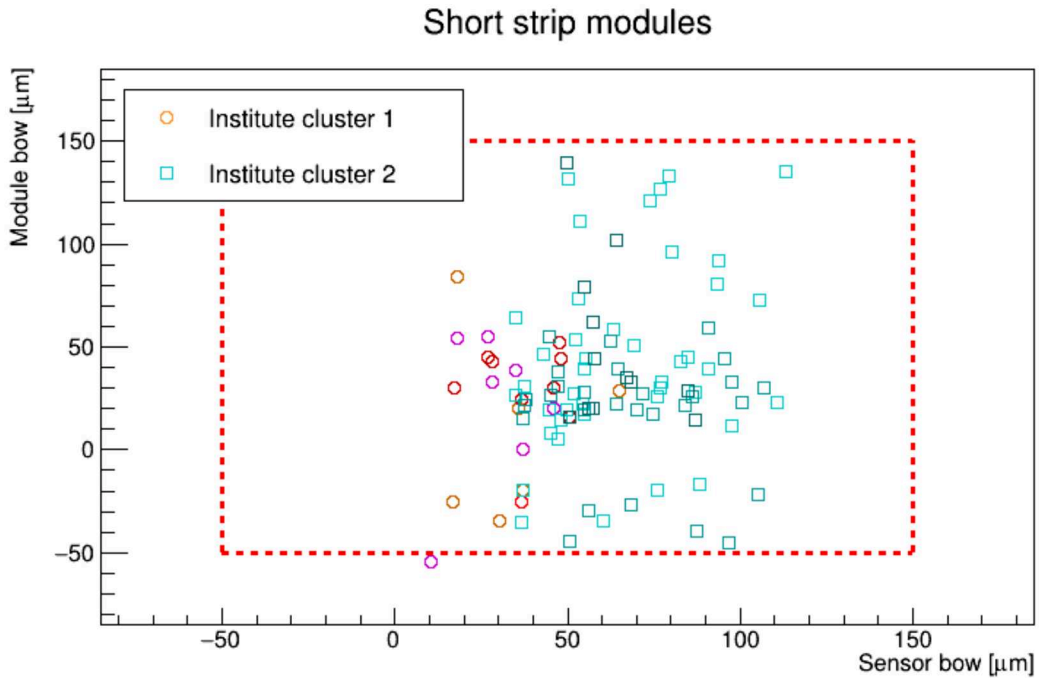
Figure 6. Sensor vs. module bow (shape coefficient) for barrel SS modules.

The typical module shape coefficient of a completed module is a small positive value, which is comparable to the intrinsic shape of an individual sensor in its free state. Sensor shapes are measured on bare sensors, prior to module assembly as part of a separate sensor QC regime. Intrinsic sensor deformation is known to be an effect of the sensor manufacturing process. Sensor deformation is not significantly affected by the module assembly process. Figure 6 shows that the sensor and module shapes are uncorrelated, but similar in value.

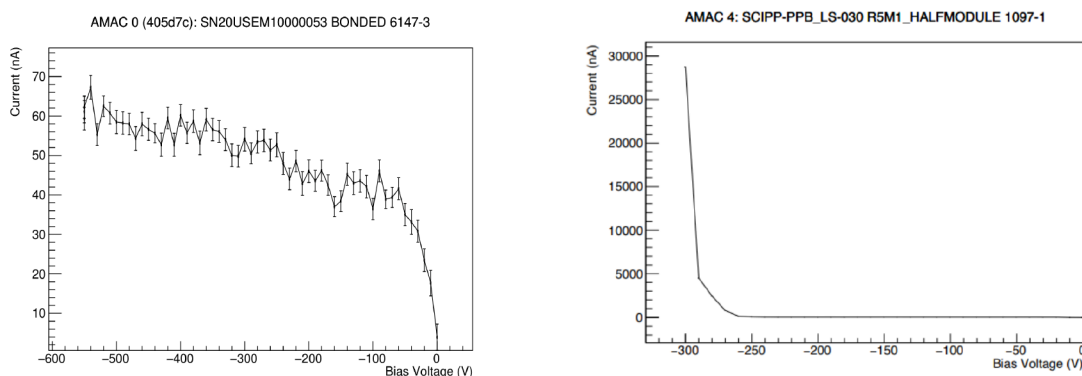
(a) IV test that passes with no early breakdown.

(b) IV test with early breakdown at about -270 V.

Figure 7. IV tests for ATLAS ITk strip modules.

Modules that exceed the limit for leakage current during IV tests may be experiencing early breakdown. Breakdown is a behaviour in which rapidly increasing leakage current is observed at a given sensor voltage. Early breakdown is defined as breakdown occurring below the nominal operating value of -500 V. An example of an IV test of a module that experienced early breakdown is shown in figure 7(b).

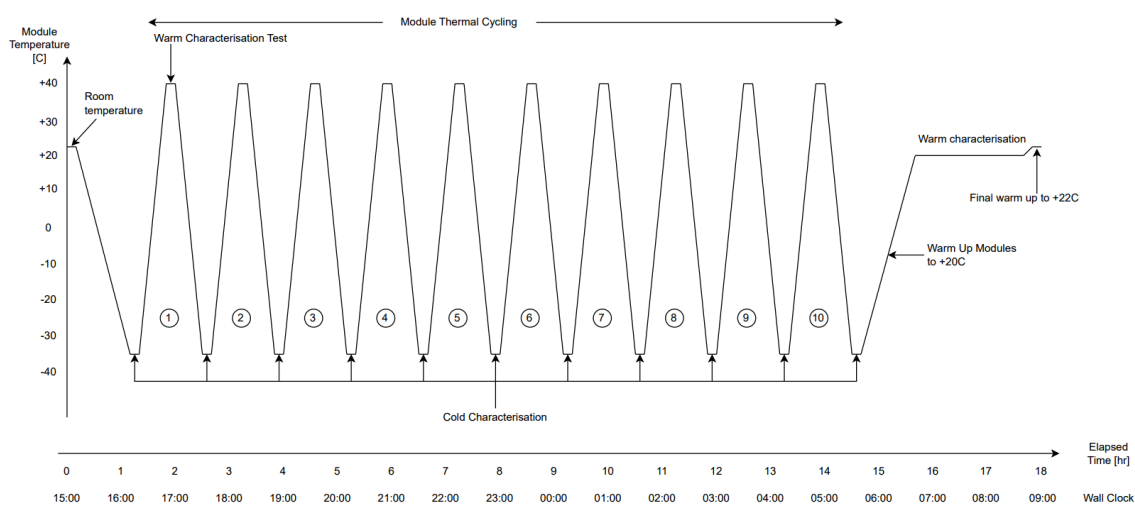
Figure 8. ATLAS ITk strips module QC thermal cycle sequence. Temperature as a function of elapsed time during a thermal cycling test, in the original cycling regime. Reproduced from [7]. The Author(s). CC BY 4.0.

Thermal cycling is done on multiple modules in parallel inside an insulated cold-box that is light- and air-tight (keeping relative humidity below 1% to avoid condensation during the cycle). The cold-box holds multiple aluminum chucks, on top of which rest the test jigs. The module is screwed into an aluminum support frame that is held by the test jig. Temperature control of the module is achieved through the jig's contact with Peltier elements mounted on the chuck, in turn connected to an external chiller. The module temperature during cycling is taken to be defined by the chuck temperature. Figure 8 displays the temperature sequence of the thermal cycling regime.

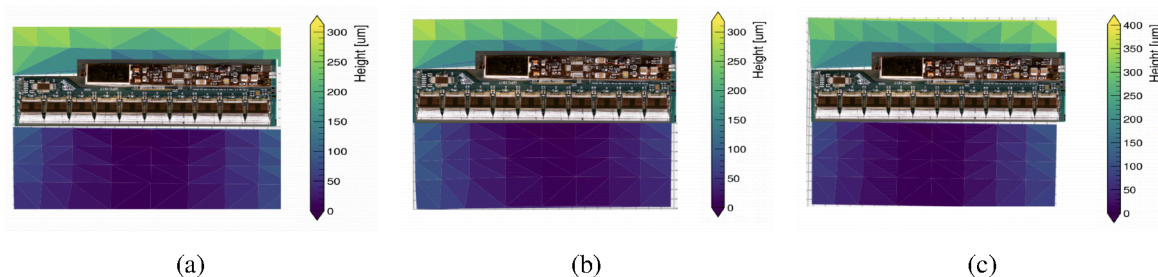
Figure 9. Shape measurements of measured height as a function of module position for LS modules. The three modules are included in the data set used in figure 10. The modules show an increase in shape coefficient that falls outside of the acceptable threshold. Prior to cycling, all three modules had shape coefficients within the threshold. Reproduced from [7]. The Author(s). CC BY 4.0.

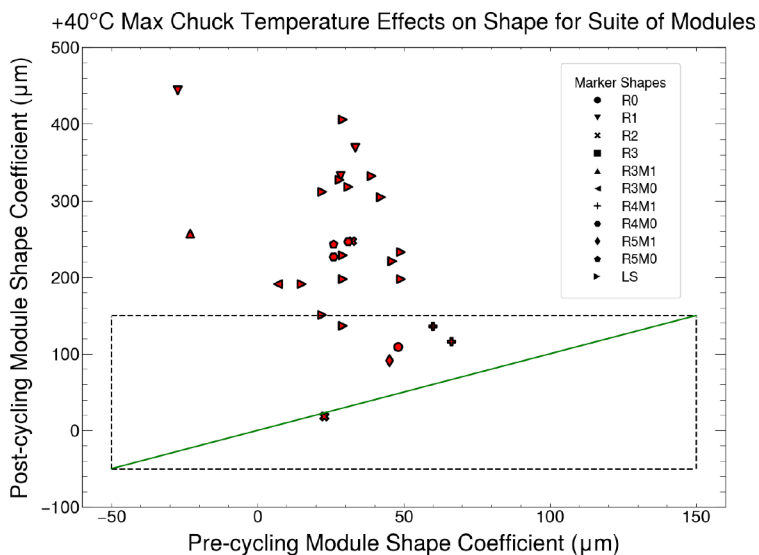
Figure 10. Post-cycling shape for modules thermally cycled to +40 °C ceiling. The dotted lines indicate the thresholds for the acceptable shape coefficient for modules to proceed to loading. Modules that fall upon the green diagonal line have their module shape unchanged before and after thermal cycling.

The observed increase in module deformation post-loading could not be caused by the loading process, as loading would only deform modules to within the acceptable threshold. Post-cycling shape measurements taken prior to loading revealed that the thermal cycling process had added to the original module deformation, represented by an increase in the average shape coefficient of about $+0.2\text{ mm}$ after thermal cycling, compared to a maximum allowed shape coefficient of $+150\text{ }\mu\text{m}$, see figure 10.

The plot of post-cycling shape coefficient against pre-cycling shape coefficient is shown in figure 10. Although these modules were within specifications before thermal cycling, 78% of the modules in the sample exceeded the upper threshold for acceptable shape coefficient post-cycling.

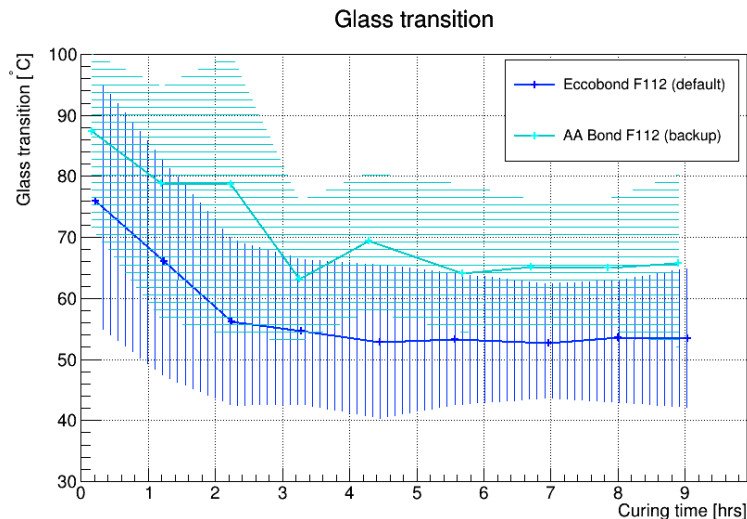
Figure 11. T_g of Eccobond F112 as cured for module assembly, measured using a Differential Scanning Calorimeter.

The quoted T_g of the glue, Eccobond F112, used in bonding the flexes to the sensor is around $+100^\circ\text{C}$ [10] for the nominal curing procedure. However, the measured T_g was about $+55^\circ\text{C}$, falling within the temperature range of a powered module. The lower T_g can likely be attributed to the non-standard curing process, as instead of applying the recommended post-cure at elevated temperature, module curing occurs at room temperature, which is known to affect the final thermo-mechanical glue characteristics. Figure 11 shows the T_g of the glue cured in this fashion, measured using standard techniques of Differential Scanning Calorimetry [11].

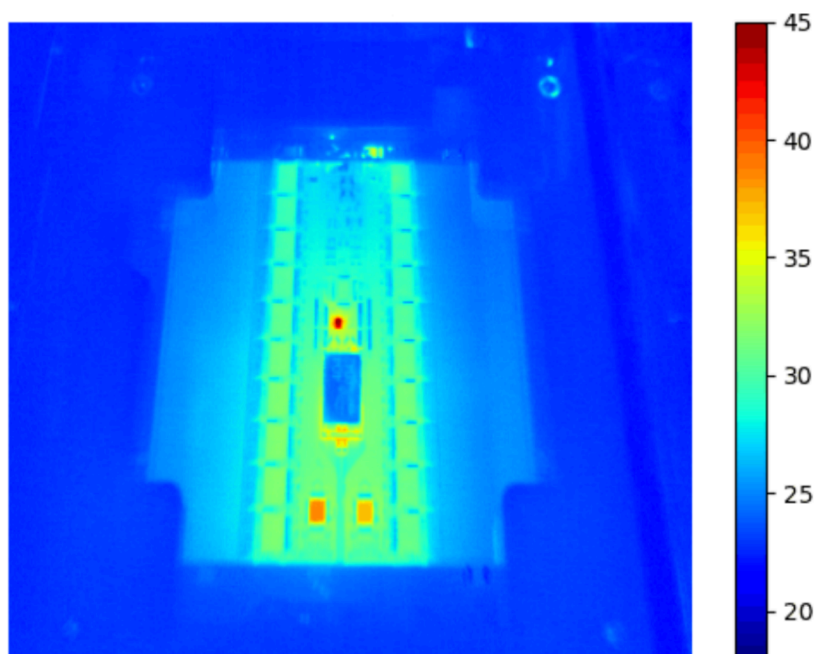
Figure 12. Thermal image of a barrel module operated at room temperature. The temperature scale is measured in °C. The highest temperature regions are around the powerboard and hybrids, as expected, the highest temperature points in these regions are the linPOL and HCCs (small chips with high power density). The overall flex temperatures are 27 °C above the nominal chuck temperature.

The absolute powerboard temperature was measured at more than $+45^\circ\text{C}$ in room temperature environment operation, as shown in figure 12. This suggests that in thermal cycling to $+40^\circ\text{C}$ chuck temperature, the absolute module temperature exceeds $+45^\circ\text{C}$ around the powerboard.

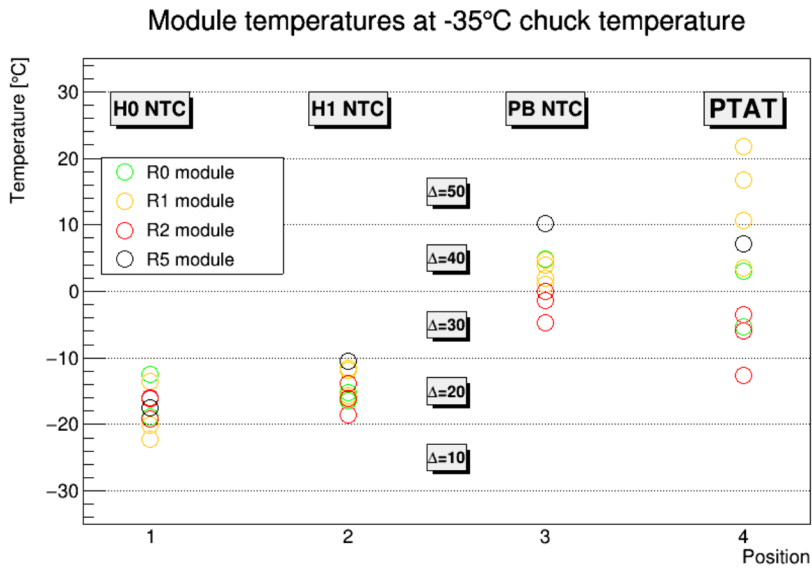
Figure 13. Module temperature measured at the cold floor (chuck temperature of -35 °C) of the thermal cycle for endcap modules. The temperatures are measured at the positions of the thermistors on the hybrids (H0 and H1 NTCs) and on the powerboard (PB NTC). The temperature as measured by the proportional to absolute temperature channel (PTAT) is also reported. The y-axis measures the absolute module temperature, with the temperature deltas showing the module temperature relative to the chuck.

Measurements of module temperatures when in the cold stage of the thermal cycle show that the thermistor on the hybrid and powerboard flexes measures a relative temperature between 50°C to 70°C above the chuck temperature, see figure 13. The large temperature difference between the module and the chuck is what allows the module temperature to surpass the glue T_g once the chuck reaches the temperature ceiling.

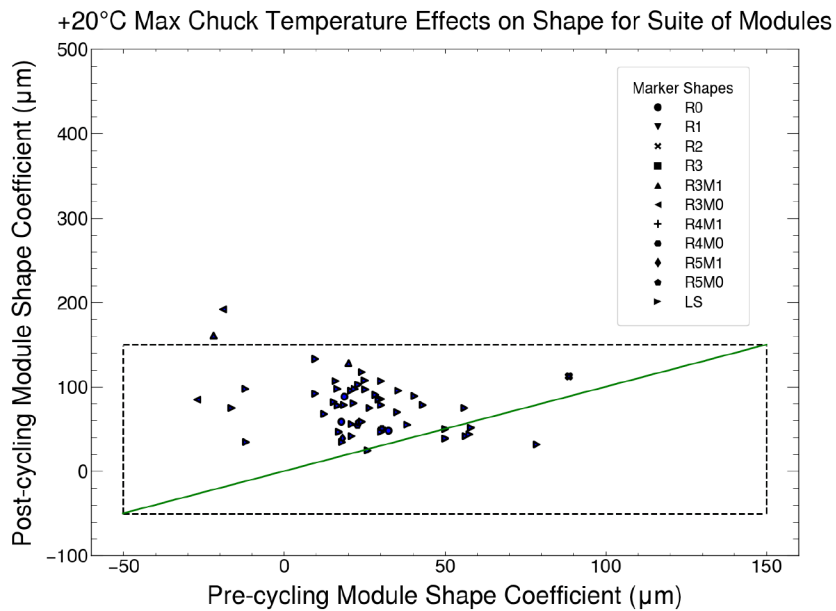
Figure 14. Post-cycling shape coefficient for modules thermally cycled to +20 °C ceiling. Most modules fall near the green line, indicating the shape coefficient is similar before and after thermal cycling.

performed with a lower ceiling temperature of +20 °C to check the impact on the module shape. The resulting plot for the modified protocol is shown in figure 14.

The sample of modules that were thermally cycled to +20 °C had minimal change in shape post-cycling, with 63% of modules having similar shape coefficients before and after cycling. The non-standard cure procedure for the glue had lowered the glue T_g to a temperature that could be exceeded at the thermal cycle ceiling of +40 °C. Thus, thermal cycling to +40 °C had allowed the absolute module temperature to exceed the glue T_g and caused a post-curing of the modules at an elevated temperature.

Modules cycled with the modified protocol lacked permanent deformation and had post-cycling shapes measured within specification. Based on this analysis, the updated thermal cycling regime brings modules to a maximum chuck temperature of +20 °C in order to prevent deforming the modules in QC. The modified ceiling temperature of +20 °C is representative of the full range of temperatures planned during detector operation.

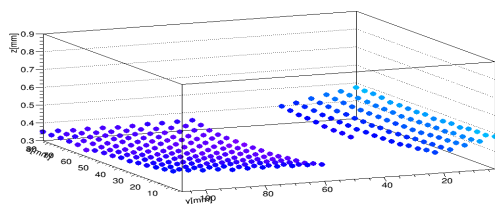
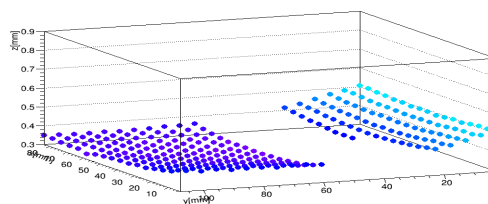
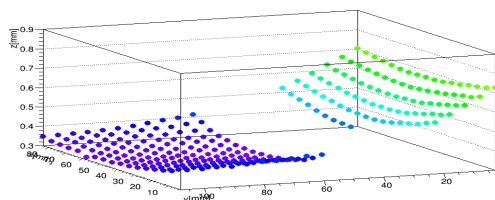
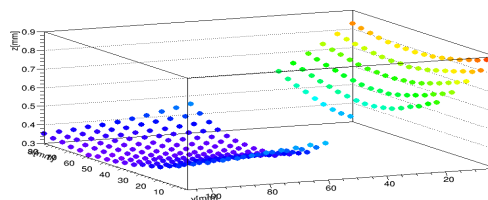
(a) Module held at +30 °C, measuring a shape coefficient of +158 μm

(b) Module held at +40 °C, measuring a shape coefficient of +200 μm

(c) Module held at +50 °C, measuring a shape coefficient of +420 μm

(d) Module held at +60 °C, measuring a shape coefficient of +580 μm

Figure 15. Module shape measurements taken following exposure to increased temperatures.

To confirm the effect of high temperatures on module deformation, a module was held at different elevated temperatures, allowed to cool to room temperature, and the module shape coefficient was measured following the temperature cycle. The module was held at the maximum temperatures for at least 30 minutes, with the module shape measurement done at +21 °C, shown in figure 15. For these tests, the module was not mechanically constrained, and remained unpowered through the whole cycle, such that the module temperature would be uniform across all components.

Monitoring the module shape over a range of increased temperatures showed that temperatures above +40 °C led to a permanent module deformation towards higher shape coefficients. This measurement confirmed that the adhesive's glass transition temperature is lower than quoted in the material data sheet and that surpassing it can lead to module deformation.
